# **Investigations on Safety Measures for Lifts and Escalators; Outcomes from the Researches Funded by the Building Standard Development Promotion Program, Japanese Ministry of Land, Infrastructure and Transport (MLIT)**

## **(Loading Tests for Full-scale Model to Confirm the Critical Strength of Existing Escalator Truss During Severe Earthquakes)**

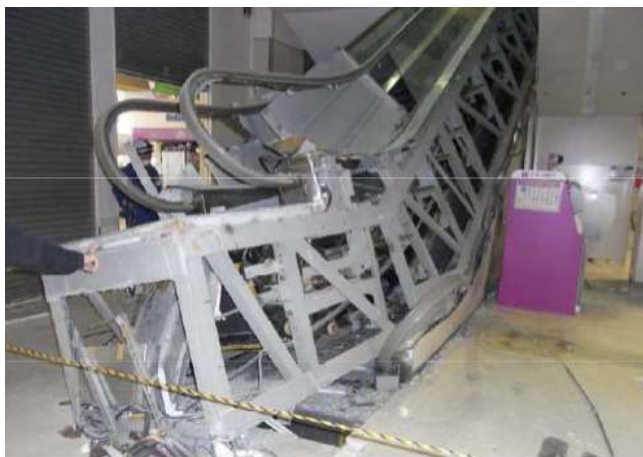
Due to the main shock, four escalators that were installed in three shopping malls dropped from the upper floor to the escalator on the lower floor. Figure 1a, 1b and 1c respectively show examples of fall-off accidents of escalators [1]. Because, in conventional seismic design for shopping centre design as described in 1.3, value of story drift is becoming extremely large especially against the severe earthquake such as Great East Japan Earthquake, the criteria of the overlap allowance between escalator truss and the lateral beam of the building where the escalator is placed on must be reviewed.

**Figure 1a Shopping centre in Saiwai-cho, Sendai City**

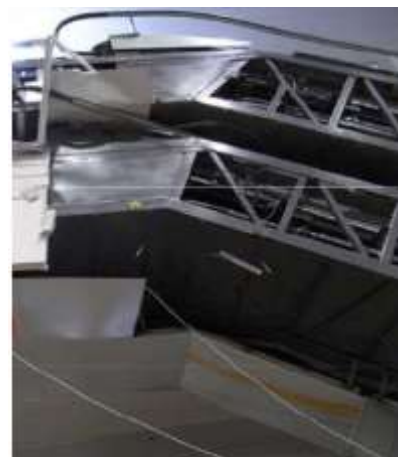
**Figure 1b Shopping centre in Izumi-Osawa, Sendai City**

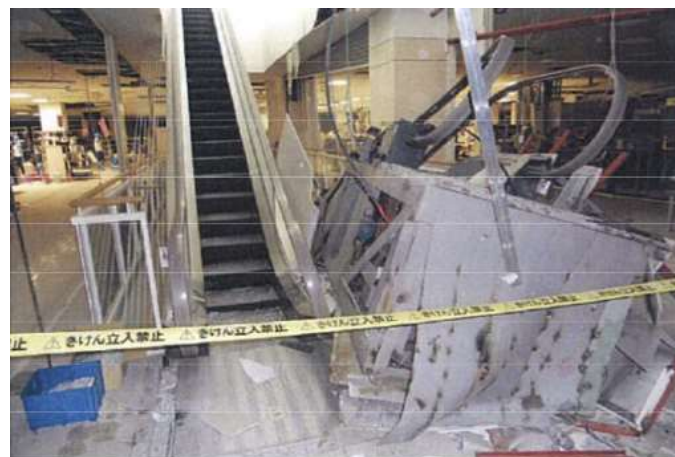
**Figure 1c Shopping centre in Koriyama City, Fukushima Pref.**

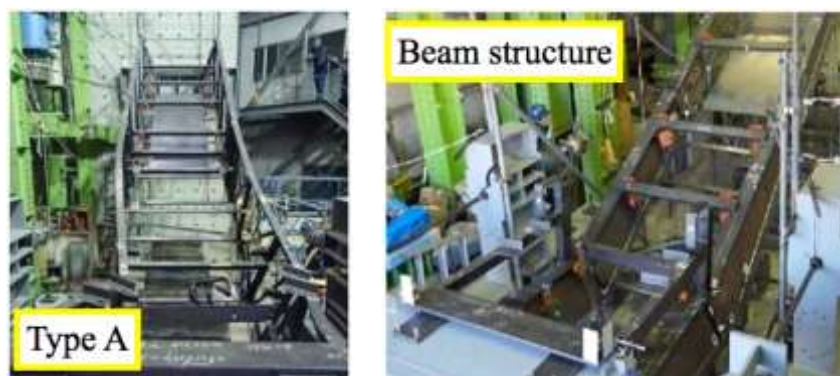
In the series of experimental tests, the deformation position was the upper chord material located in the lower bent portion or the intermediate part of the diagonal material although the progress of deformation varied depending on each other and on the shape of the section steel used. In addition, in the beam structured escalator truss, deformation occurred at the lower bent portion.

**Figure 9 Deformation state of the type A and beam structure escalator truss**

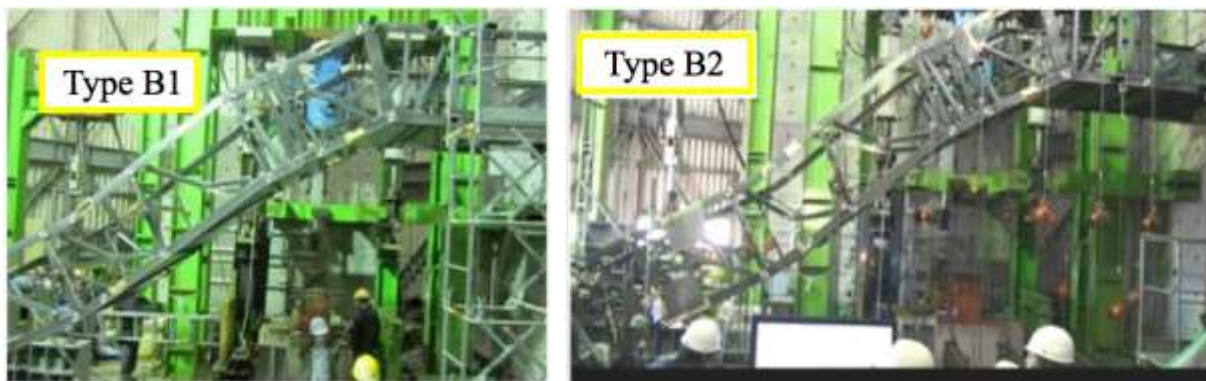
**Figure 10 Deformation state of the type B1 and B2 escalator truss**

\* In the test for Type B2 escalator truss, buckling deformation appeared on the member at the forced displacement around 40 mm, so it was unloaded only when the forced displacement was 60 mm.

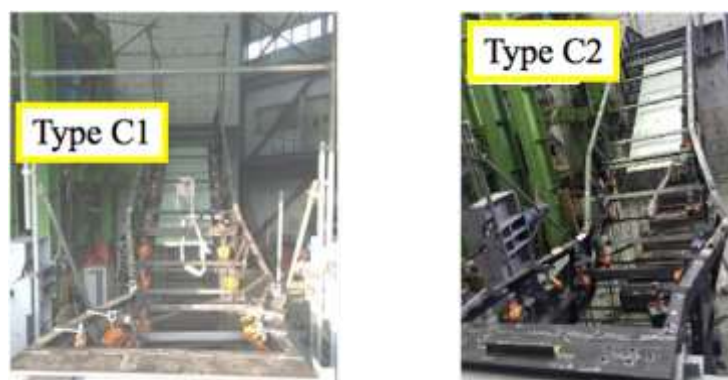
**Figure 11 Deformation state of the type C1 and C2 escalator truss**

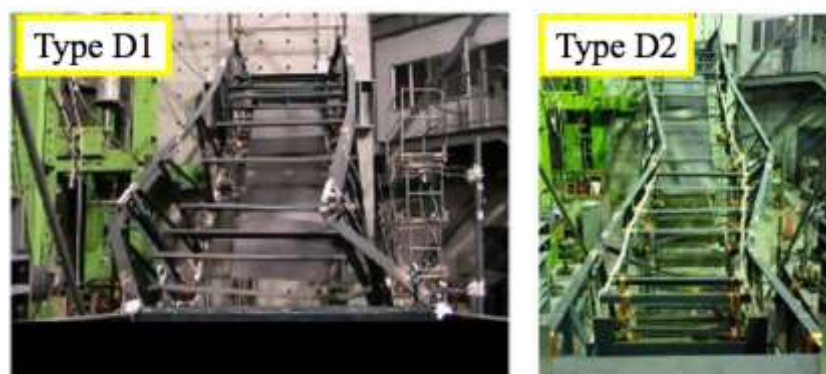
**Figure 12 Deformation state of the type D1 and D2 escalator truss**
