Report on Seismic Damages of Lifts and Escalators by Large Earthquakes in Japan

Additionally, investigation regarding lifts and escalators was mainly carried out by the Japan Elevator Association. This paper provides a summary of the investigation regarding the lifts and escalators to contribute to improving the seismic design for forthcoming destructive earthquakes. Typical damage of the lifts and escalators utilized in buildings are also shown in this paper. Although many of the buildings were hit by unexpected massive earthquakes, the damage of the lifts and escalators designed according to the newly Seismic Design Guideline issued in 2009 seems to have been reduced a certain level.

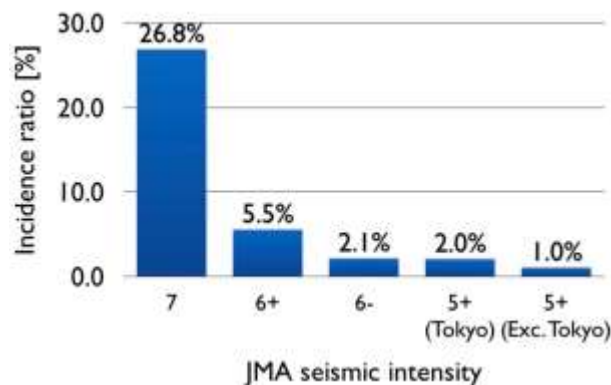
Figure 1 shows incidence ratio by JMA seismic intensity scale. The JMA seismic intensity is calculated from ground acceleration during an earthquake considering frequency components, and the minimum level is 0, the maximum level is 7. As shown in Fig. 1, more than 1/4 of lifts that were installed in area of the JMA seismic intensity 7 were damaged.

Figure 1 Incidence ratio of lift by Japan Meteorological Agency seismic intensity scale (Great East Japan Earthquake in 2011)

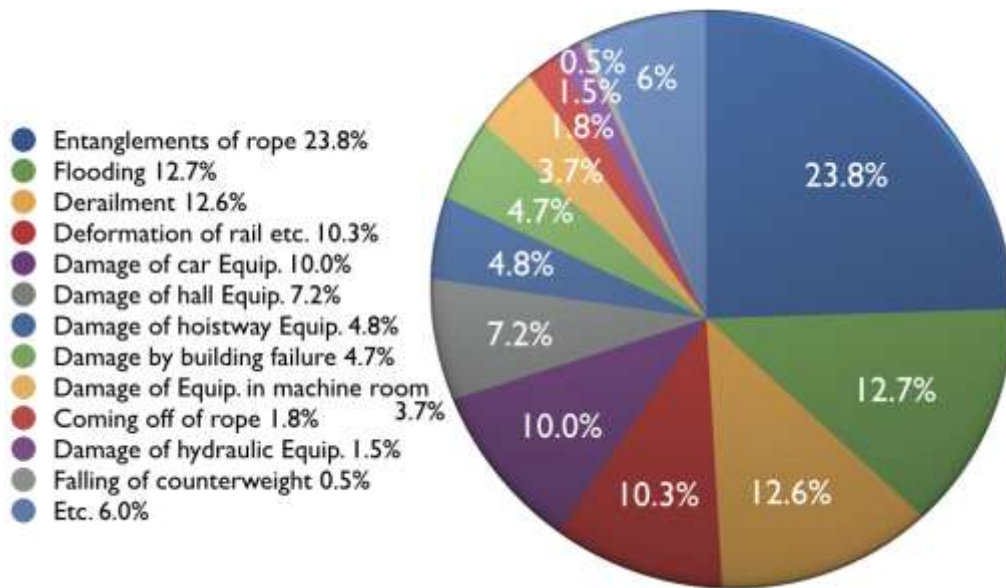
Figure 2 shows damage of lift by parts. As shown in Fig. 2, entanglements of ropes accounted for 1/4 of total damage. The reason was that large areas in Japan including Tokyo where many buildings exist were affected by the earthquake. Vibration of ropes relates to height of a building, length of a rope, the ground condition and so on. For example, Tokyo is located on a sedimentary layer, and long period seismic waves are excited by the layer. In general, high-rise buildings and long wire ropes have long natural period, so that there are risks of resonance.

Then many damages by flooding also occurred. This is a one of the features of the Great East Japan Earthquake. Other mechanical structures were also damaged by large tsunamis [7].

In addition, a lot of damage that was caused by interaction with buildings such as entanglements of ropes, deformation of rails, damage of hoistway equipment and so on occurred. Close cooperation with structural engineers of buildings is strongly recommended to reduce the damage of lifts.

Falling of counterweight blocks occurred, similarly to in past destructive earthquakes. Although the numbers of falling counterweight blocks were few, it may cause human damage. However no falling of counterweight blocks in lifts that were designed by applying Seismic Design Guideline issued in 2009 occurred. Therefore, the guideline was revised effectively.

Figure 2 Damage of lift by cause (Great East Japan Earthquake in 2011)

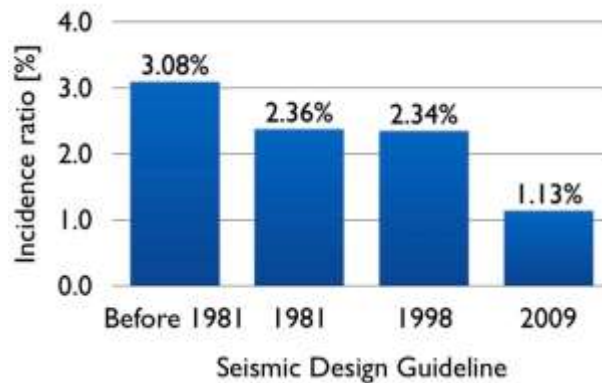
Figure 3 shows relationship between edition of Seismic Design Guideline and incidence ratio. Incidence ratio decreased with the edition, thus revisions were effective.

Figure 3 Relationship between edition of Seismic Design Guideline and incidence ratio of lift (Great East Japan Earthquake in 2011)

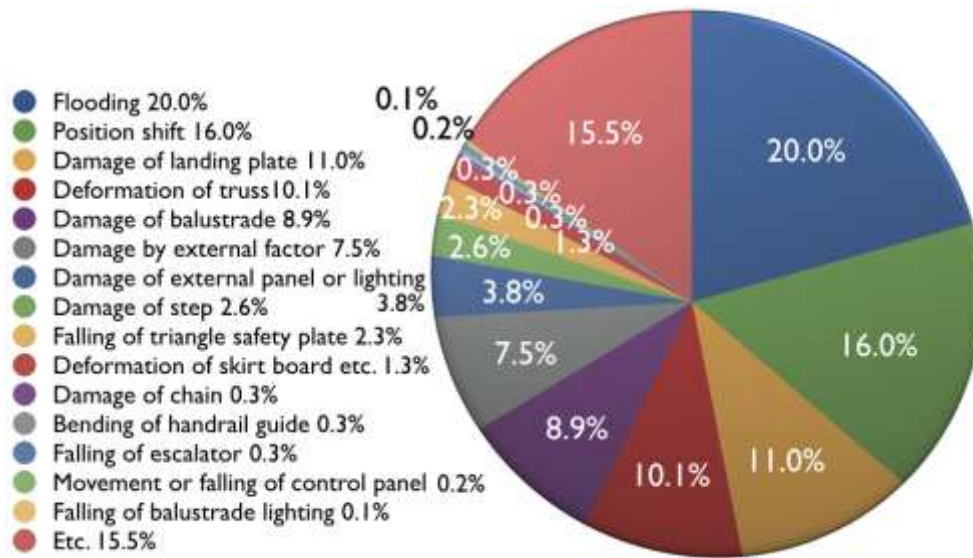
Figure 4 shows damage of escalators by parts. As shown in Fig. 4, damage by flooding, one of the features of the Great East Japan Earthquake, accounted for 1/5 of total damage. Apart from that, damage such as position shift and damage of landing plates occurred. This damage might be caused by interaction between buildings and escalators.

In addition, 4 escalators in shopping malls fell from floors of buildings. Although the number of falling escalators were few, it may cause human damage if passengers are on the escalators. Therefore, a project and revision of the guideline regarding fall accidents were carried out after the earthquake.

Figure 4 Damage of escalator by cause (Great East Japan Earthquake in 2011)

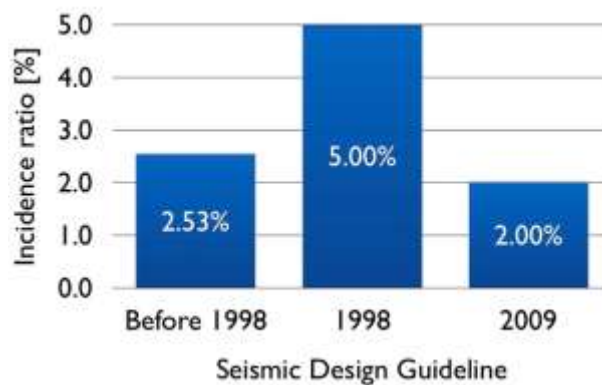
Figure 5 shows the relationship between edition of Seismic Design Guideline and incidence ratio. Damage incidence ratio of escalators before 1998 was small compared of escalators that were designed by applying Seismic Design Standard issued in 1998. On the other hand, the ratio of escalators after 2009 decreased.

Figure 5 Relationship between edition of Seismic Design Guideline and incidence ratio of escalator (Great East Japan Earthquake in 2011)

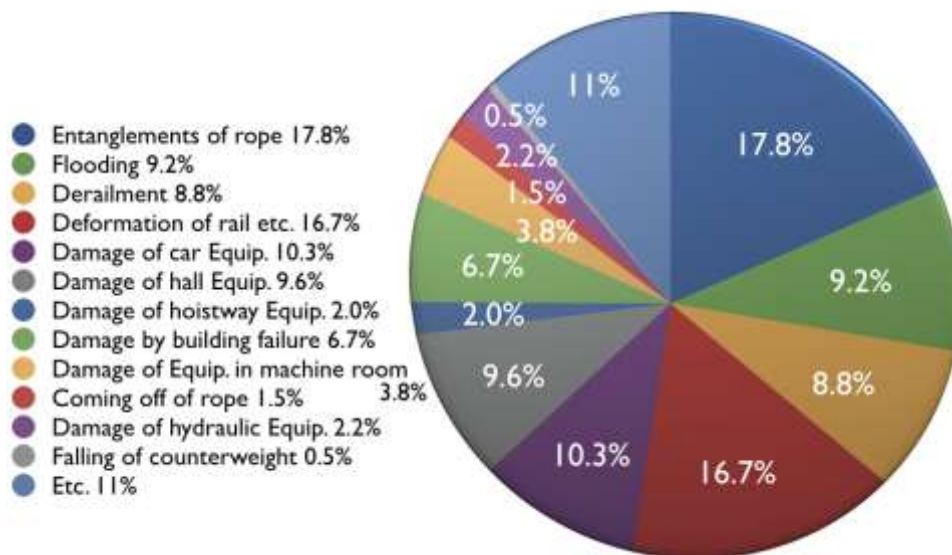
Figure 6 shows damage of lift by parts. As shown in Fig. 6, damage related to buildings such as entanglements of ropes, damage of rails, entrance halls and so on mainly occurred. Five cases of falling of counterweight blocks occurred, but these happened at lifts that were designed by using the Seismic Design Guideline issued in 1981 or before.

Figure 6 Damage of lift by cause (Kumamoto Earthquake in 2016)

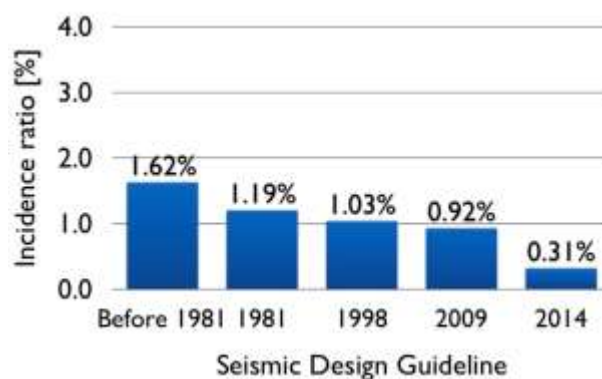
Figure 7 shows the relationship between edition of Seismic Design Guideline and incidence ratio. Incidence ratio decreased with the edition as well as the Great East Japan Earthquake, thus effectiveness of the revision was confirmed.

Figure 7 Relationship between edition of Seismic Design Guideline and incidence ratio of lift (Kumamoto Earthquake in 2016)

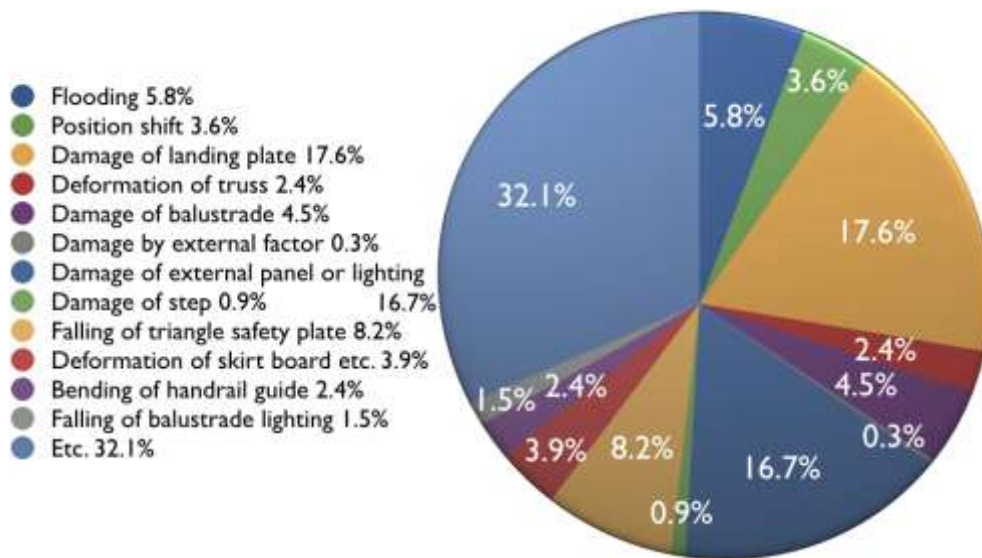
Figure 8 shows damage of escalators by parts. As shown in Fig. 8, damage mainly occurred in landing plates, external panels or lighting, and this damage was related to interaction with building. In addition, no fall accident of escalators occurred.

Figure 8 Damage of escalator by cause (Kumamoto Earthquake in 2016)

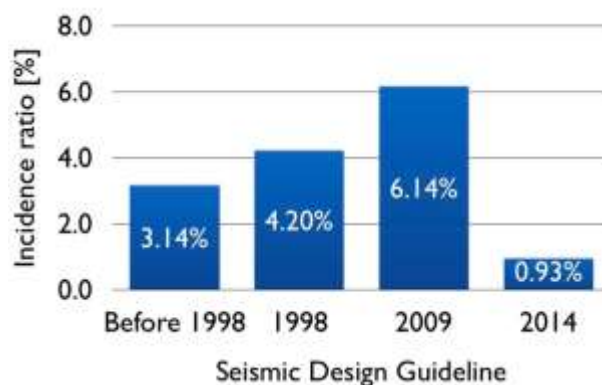
Figure 9 shows relationship between edition of Seismic Design Guideline and incidence ratio. Although incidence ratio of escalators after 2014 was small, the ratio increased with the edition. In order to clarify reason of this result, investigation in consideration of buildings is needed.

Figure 9 Relationship between edition of Seismic Design Guideline and incidence ratio of escalator (Kumamoto Earthquake in 2016)
