## UNSAFE, DESPITE GOOD ELEVATOR ENGINEERING AND CODES

D. A. Swerrie, P.E. & C.E.I., Safety Consultant, Swerrie, Inc.,  
244 San Felipe Way, Novato, California 94945, U.S.A.

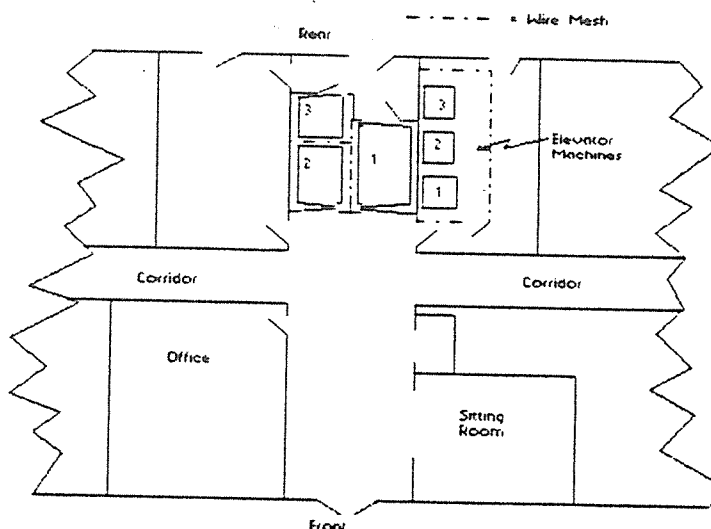
FIGURE 1

Elevators # 1 & # 2 were duplexed and were the elevators used by the tenants and guests. See Figure 1. Elevator # 1 was slightly larger and had a rear entrance on the first floor only. That entrance served the rear, or delivery, entrance to the building. It provided a way to move furniture in and out without crossing the lobby. Elevator # 3 was a service elevator, serving the delivery or rear building entrance and the kitchen on the seventh floor only. Its openings were towards the rear. The elevator machine room was in the electrical distribution room on the first floor. Elevator # 3 and the rear entrance to elevator # 1 were equipped with manually operated swing hoistway doors. All other doors were of the power operated, horizontal sliding type. Elevators # 1 & # 2 were equipped with Fireman's Return and Service.
