LIFT SAFETY IN SPAIN

Dr. Eng. Julián Jiménez

Lift Consult S.L.

ABSTRACT

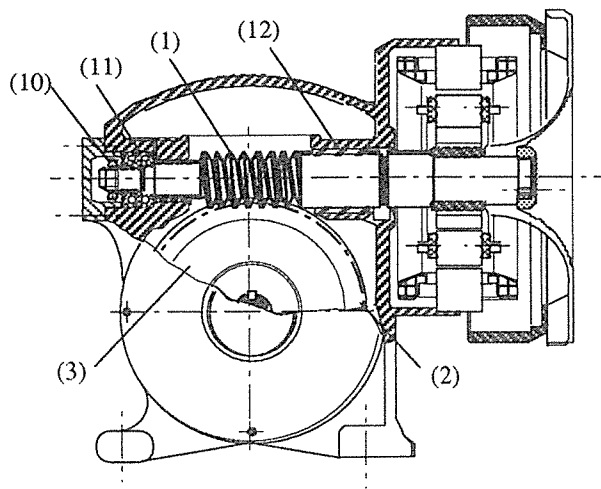
Figure 1
Worm gear
Cross-sectional view of the worm shaft

- Inadequate section of the nucleus.
- Inadequate modulus of the teeth.
- Inadequate transition radius between the shaft teeth and its nucleus.
- Inadequate radius of teeth foot.
- Inadequate teeth hardening, which introduces strong residual stresses.

These problems mean the shaft insufficient fatigue endurance, with breaking of teeth and even of worm shaft, having as result an uncontrolled motion of the lift car.

- f) The fixing nut of axial bearing is grown slack and finally goes off, causing shaft ejection.
- g) Excessive clearances, in the axial bearing as well as in the radial one.
- h) Insufficient service life of both bearings.
- i) Inappropriate keyways of the shaft in the fly-wheel and in the motor.

In some designs, even in recent ones, the distance between the bearings of the worm shaft is too short. For this reason, the shaft is too rigid, lacking the necessary capability to absorb impacts. In these cases, the breaking of the shaft can be the result of strikes, surpassings of the car travel, its shocks or the collision of the counter-weight against the machine room floor slab or buffers.

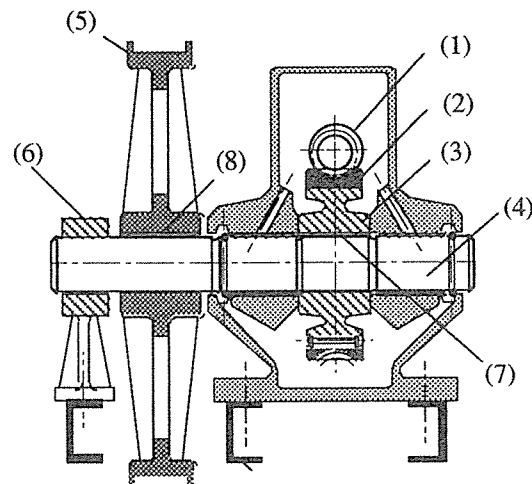
Figure 2
Three bearings worm gear
Cross-sectional view of the main shaft

The main shaft is an especially critical part in the traction drives with external bearing, due to the phenomenon of fatigue under reversed bending. The section more critical, where the greatest part of the fissures and shaft breakings take place, is logically that corresponding to the sheave seat. Some of the factors more influential in an unfavourable behaviour of the main shafts towards fatigue are the following :

- a) Insufficient sections.
- b) Inadequate transition radius between adjacent sections of different diameter.
- c) Lubrication grooves with insufficient radius.
- d) Using of unsuitable steels, especially of high breaking strength.
- e) Faults in the alignment of the external bearing, which introduce additional stresses.
- f) Insufficient stiffness of the gear frame, in terms of the foreseen supports for the same.
- g) Inappropriate keyways and keys for the sheave or worm wheel seating, with excessive sizes or with insufficient transition radius.
- h) Unsuitable sheave seating, with excessive or insufficient fitting.
- i) Drill holes and notches for the fixing of accessories.
- j) Excessive clearances in the bearings.
- k) Excessive roughness of the surface, specially in the sheave and worm wheel seatings.

In addition to these problems of design and construction, there are other ones caused by unsuitable erection and maintenance methods, such as :

- l) To proceed with the disassembling of the traction drive when this one reaches the site, to make easier its raising until the machine room and the subsequent new assembly.
- m) Utilization of unsuitable oils, inadequate oil level, also without being changed regularly.
- n) Knurling of the shaft in the sheave seating zone, on the occasion of the change of sheaves, to recover the fitting lost in previous changes.
- o) By the same reason, increase of the shaft by welding and subsequent turning of the shaft.
- p) Increase of sheave keyway by welding and its subsequent machining.

With this respect, it must be pointed out that all welding on a shaft is indefectibly origin of a fissure in the same. In spite of this, we have even observed gearings where the worm wheel was fixed to the shaft by welding.

This problem of fissures and breakings of shafts has reached a so large scale that an important lift company has launched expensive control programmes of these shafts by ultrasounds to detect the presence of fissures and to avoid possible breakings. Nevertheless, as the appearance of a crack can take place at any time and its growth can be very fast, the only effective way to prevent this kind of accidents is to carry out an evaluation of the design and the real condition of each drive, correcting its faultinesses when its repair is possible and, otherwise, replacing it for other gear designed, manufactured and maintained with suitable approaches.

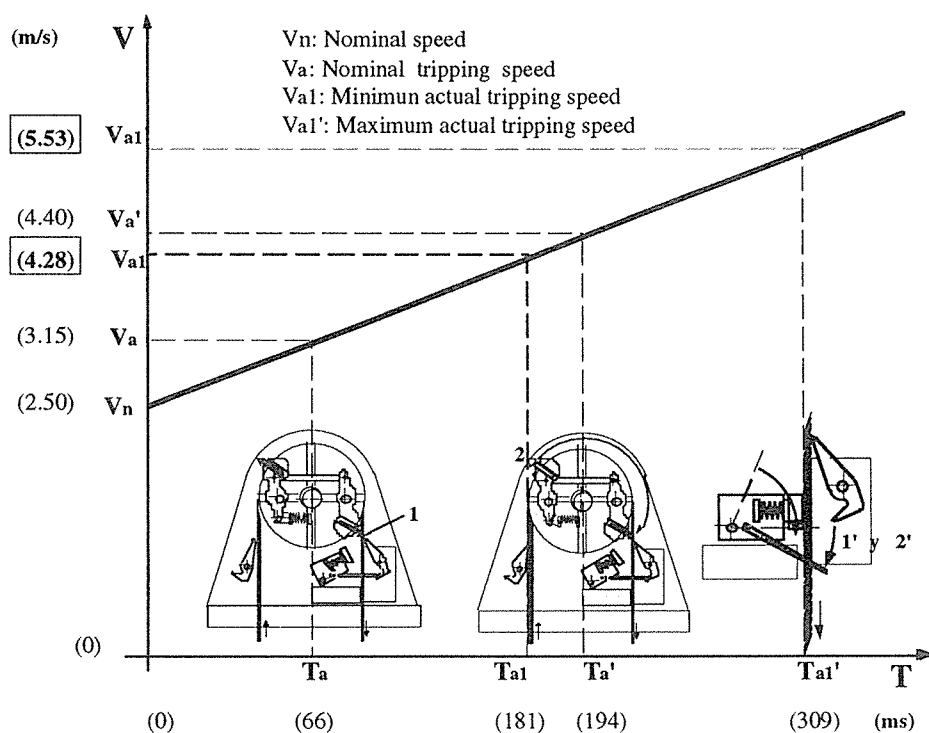
Figure 3
Centrifugal
Overspeed governor

A kind of overspeed governor very common is the one composed by two movable masses that turn together with the sheave and which are separated by the action of the centrifugal force. When a certain speed is exceeded, one of the masses actuates a trigger which releases a swinging jaw that falls and brakes the governor rope against other fixed jaw, placed in the base of the mechanism. This type of overspeed governor is dangerous due to the excessive delay which is produced between the moment when the nominal tripping speed is reached and the

moment when the governor rope is really braked. In fact, it can happen that one of the movable masses passes near the trigger at a speed lightly lower than the tripping one. In this case the shot only will take place when the sheave has completed half a turn. Meanwhile, the car will have gone down in free fall a height equal to half the sheave development and its speed will have been increased consistently. On the other hand, the time spent by the swinging jaw in falling and braking the rope imposes a new delay.

As the Figure 3 shows, a governor of this kind can have a real tripping speed between 3.97 m/s and 5.03 m/s, for a nominal car speed of 2.50 m/s, against a nominal tripping speed of 3.12 m/s. Consequently, the chosen safety gear would have to be homologated to stop the car at a speed of 5.03 m/s. This kind of governor seems doesn't comply with the 9.9.7 article of the EN 81-1 code since presents an excessive answer time and an indefinite tripping real speed. However, there is a large number of these governors which have been installed, even in lifts of high nominal speed, having some of them the corresponding EEC Type-Examination Certificate, which allows them to be used with nominal speeds over 4.0 m/s. Other problems that appear in this kind of governors are those related with the rope braking, such as the clearance between the jaws, its wear and the regulation of the braking spring.

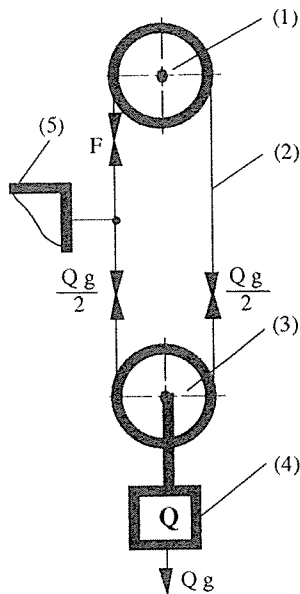
Figure 4
Overspeed governor system

In these governors the rope braking is got by the friction between this one and the sheave when this last stops by the action of the ratched device. Although this kind of governors can also present a problem of delay, depending on the number of wheel teeth and the number of ratchets, the most important problem they have is the lost of friction between the rope and the sheave, due to the wear of this last one. In these conditions, the friction force developed can be insufficient to make the safety gear operates. In the Figure 4 is shown the system made up by the overspeed governor, the rope and the tension pulley.

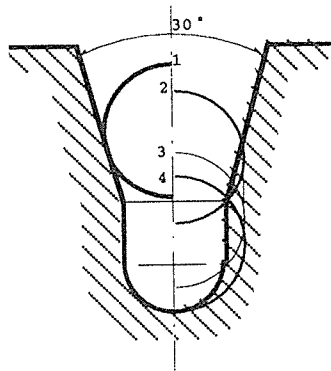
Figure 5
Wear of governor groove

As Figure 5 shows, at the same time as the groove gets wear and the rope penetrates into it, the groove shape evolves from a groove in V to a groove in U, decreasing the apparent coefficient of friction in accordance with the known formulas. Accepting an actual coefficient of friction $\mu = 0.125$, the available friction force with a new groove (1), as the one represented in the figure, would be of the order of 610 N, enough for operating a safety gear that requires an activating force of 305, taking into account the safety coefficient of 2 the EN 81 code prescribes. Nevertheless, with the woreed groove the available force would be only 110 N, inadequate to activate the safety gear. The usual cast iron, with a hardness of the order of 200 HB, is unsuitable since gives rise to a fast wearing of the sheave. It's necessary to harden the sheave in the groove zone, by induction hardening until it reaches a hardness of 50 HRC approximately. However, it's difficult to reach an uniform hardness in this zone due to the lack of uniformity of the material thicknesses there.

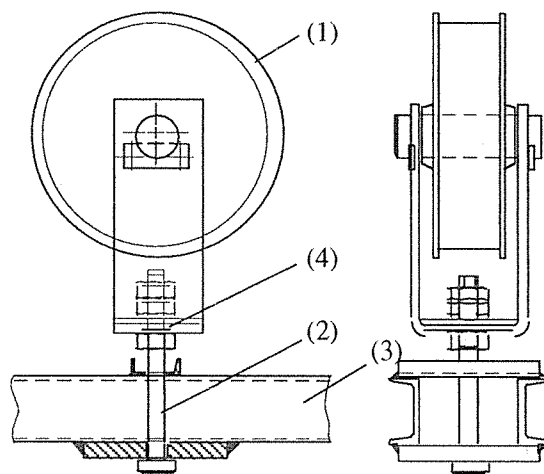
Figure 7
One bolt car suspension

Figure 7 shows a typical one bolt-suspension, as the one was cause of the mentioned Bellvitge Hospital accident. The bolt, probably calculated simply under static tensile load and which, under this kind of load, presented indeed an enough coefficient of safety, got broken under alternating bending loads, due probably to fastening system and eccentricities in the load and in the ropes tension. Faults in the thread machining gave rise to a high stress concentration in the bottom of it, causing the bolt breaking in one of those sections near to the suspension fixing.

While it could be thought that, after a so serious accident as Bellvitge one, all suspensions of this kind would have been replaced, we still have had the opportunity to observe recently this kind of suspensions in the lifts main group of a tower in a Spanish town, although reinforced on site.

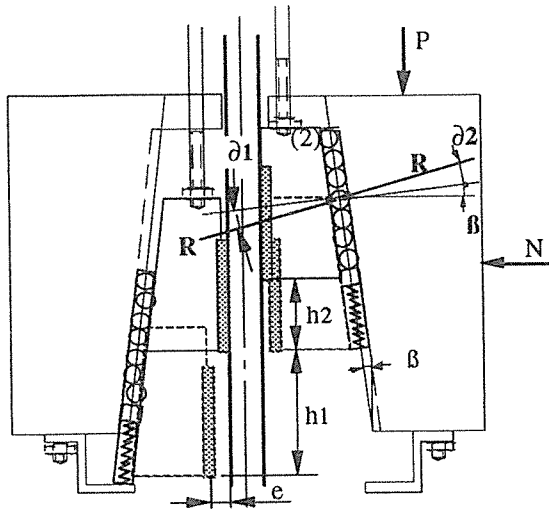
Figure 6
Progressive safety gear

Figure 6 shows a detail of the safety gear block of a very common progressive safety gear. In case of free fall, once the overspeed governor has activated the safety gear operation rods, the car keeps on falling with the acceleration of gravity a height h_1 , until the movable wedges get into contact with the guide rail. In the example of 3.2 section, the car would have reached at that moment a speed of 5.12 m/s. While the car goes down the height h_2 , the spring is

compressed and develops a progressively growing braking force until the wedges bump into the wedges box and the spring reaches its smallest length, developing from that moment a constant braking force. In the same mentioned example, depending on whether the overspeed governor works at its lowest tripping speed or at the maximum one, the car stopping distances in free fall will be 859 mm in the first case and 3263 mm in the second one, assuming that the spring is adjusted to produce a deceleration of 0.6 g. It can be noticed, thus, the great variability of the system performance just by this reason. Other factors which can have a negative influence in the working of a safety gear of this kind are the following :

i) As a result of the safety gear acting, several parts of the mechanism as the braking shoes or the movable wedges can get fissures and be broken in the course of a later activation.

a) The change in the coefficient of friction between the braking shoes and the guide rails depending on a very large number of factors, such as the speed, the superficial condition of the guide rails, the material, the superficial condition of the braking shoes, the fact that the guide rails are dry or lubricated, the kind of lubricant used in this second case, the dirtiness of contact surfaces, etc. The dependence between the coefficient of friction and the speed has been not much studied. Although some authors have proposed formulas for the same, we observe that the static coefficient of friction is conferred a value of 0.4 in these formulas. However, in our tests, we have never got values higher than 0.21, which is an important difference.

b) The great variability in the characteristics of the braking springs, especially when these ones aren't constituted by " Belleville " washers packets. On the other hand, the rust and dirtiness accumulated in these springs by time increases their internal friction, modifying their behaviour.

c) The lack of synchronism in the working of the two wedges sets due to dimensional or levers operating mechanism defects which transfers the over speed governor action.

d) The use of drawn guides instead of machined ones.

e) Using of lubricated guides, especially high pressure oils or with improving lubrication additives.

f) The dirtiness oftenly accumulated in the rollers cage, with the consequent increasing of the coefficient of friction, which can hold up the action of the wedges, break the static equilibrium condition of the whole and even prevent the wedging action.

g) In view of the little wedge angle, which a light increase of the clearance " e " (Figure 6) between the wedges and the guide rails, which usually doesn't exceed 2.5 mm, can bring about that the braking spring compression gets very reduced or its not carrying out and even that the wedges reach their extreme position without getting in contact with the guide rail. This play, is also hardly controlable with the mechanism having been assembled, in working conditions.

h) The braking shoes hardness is a very important factor. If the hardness isn't enough, the shoes can get wear out during the lift normal working as a result of the friction with the guide rails due to the mechanism unsuitable adjustment. This means a growing of the play between the braking shoes and the guide rails, with the consequences mentioned above and, on the other hand, the shoes remaining thickness can be insufficient to assure the car stopping. The GG 20 normal cast iron is inappropriate and must be used cast irons as the GGG 60 one.

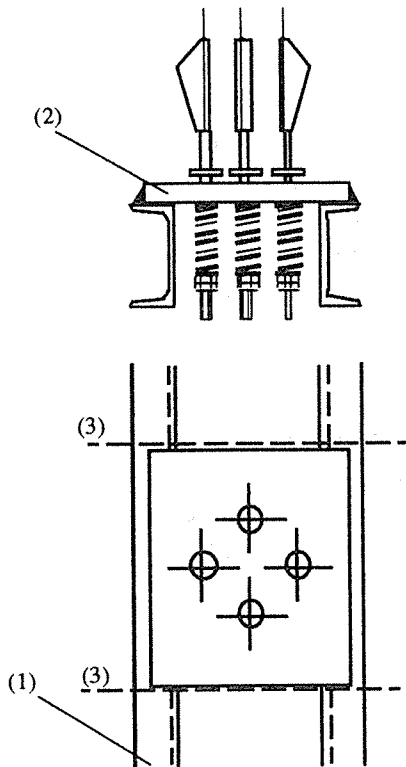
Figure 8
Welded suspension : roping factor 1

Figure 8 shows a roping factor 1 suspension with rope fixing plate welded on the frame crosshead. Figure 9 shows a roping factor 2 suspension based on the same principle. The danger of this kind of suspensions is due to the residual stresses introduced by welding as well as, in many cases, to its poor quality. There are still thousands of these suspensions installed in Spain.
