# Statistical Investigation of Lift Damages after Large Earthquakes in Turkey

**Abstract.** Lifts are expected to continue their services after earthquakes, especially in critical and strategic public buildings such as hospitals. However, from investigations carried out in the field after earthquakes, it is known that lifts are out of service due to damage to critical components. In this study, after large earthquakes in Turkey, field investigations carried out on lift installations are discussed, and the structural elements of the lifts are classified and statistically expressed. The results obtained are shown graphically, and the distribution of the damages in critical components is given. It is aimed to reveal which components should be focused on in lift design for earthquakes and the points to be taken into account in lift design for seismic test suit. Although the EN 81-77 standard was introduced in Turkey in 2014, it has been observed that the standard is not mandatory, and the structural characteristics of the damaged lifts during the period are the same.

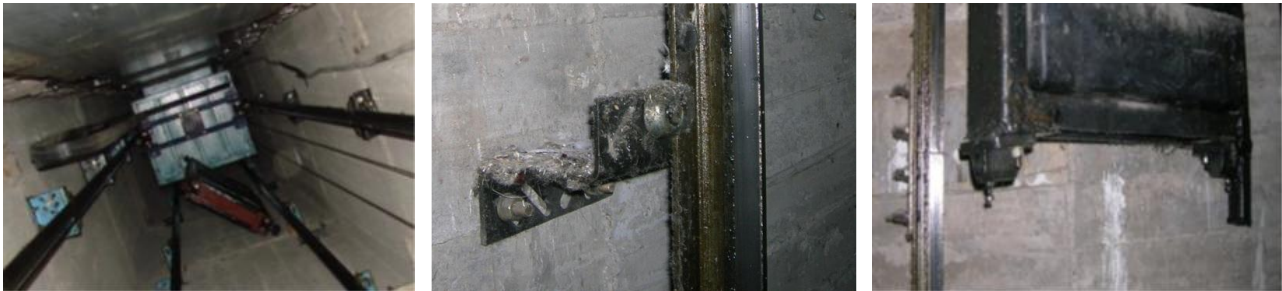
**Figure 3 Lift damage of the Van Earthquake [6]**

İmrak studied the sorts of damage to lifts following the Van earthquake. The following damage types have been observed: the counterweight derailment, the guide shoes of the counterweight frames breaking, the guide rails on the counterweight side bending, the bracket element bending, the landing

doors jamming, the rope dislocating from the pulleys and becoming damaged, the carrier ropes snagging on the bracket elements, and the falling of the counterweight weights on the car. Lift damage following the earthquake is depicted in Figure 3 [6].

After 25 lifts were examined in Van, it was observed that the counterweights came out of their guide rails, and brackets were bent, resulting in counterweight derailments and guide rails forced to break their guide shoes, as shown in Figure 3.

Imrak said that seismic switches should be used in lifts, box brackets should be used to strengthen the counterweight rails to prevent displacement of the counterweight, guide rails of sufficient size should be used, retaining plates are required under the roller guide assemblies, and anti-tripping guards are required in the lift track to prevent tripping of ropes and travelling cables [6].

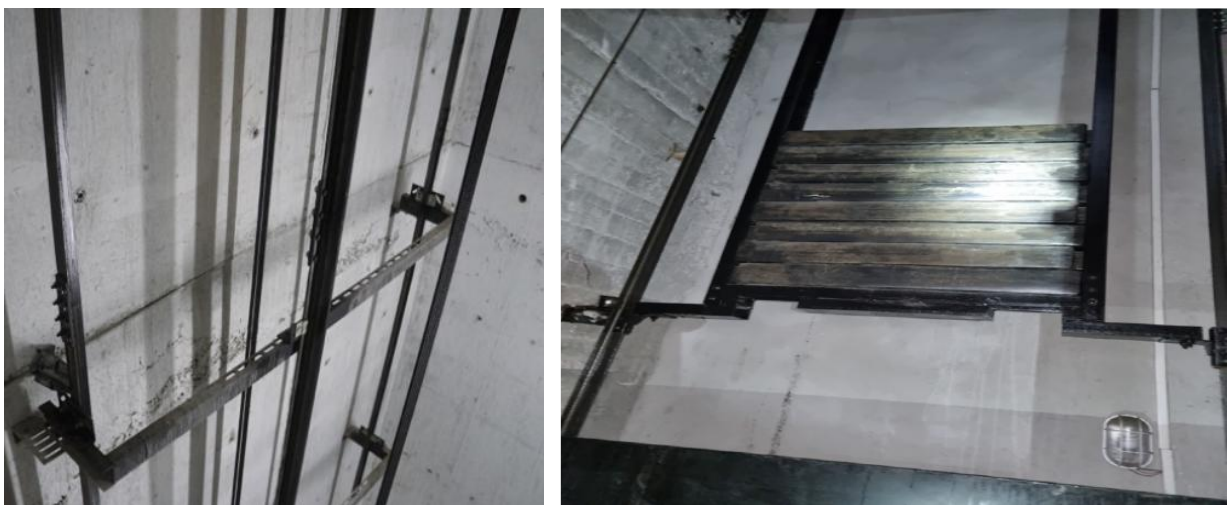
**Figure 4 Lift damage of the Kahramanmaraş Earthquakes [7]**

According to the report following the Kahramanmaraş earthquakes, the following types of damage were recorded in lifts. Some lift shafts collapsed, cabins sank to the bottom, roller guides were loose or broken, regulator ropes were damaged, rail brackets were broken, balancing cables were out of their slots or damaged, counterweights were coming out of their rails, and some of them were hitting the cabins. Lift damage following the earthquake is depicted in Figure 4 [7].

Field work was carried out in Malatya, one of the provinces affected by the Kahramanmaraş earthquakes. Although the hospital lifts examined were installed after the EN 81-77 standard was

implemented, it was observed that the brackets were not specially designed for earthquake zones. Many of them had structural damage, and the counterweight was displaced, caused by the effects of the earthquake, as shown in Figure 4.

Çelik et al. suggested that seismic switches should be used, measures for counterweight tie rods and electrically charged wire with displacement ring should be taken, an appropriate size guide rail should be used, structural support frames for seismically isolated buildings, and rope guards should be used [7].
