# **Under Lifted Buildings in the Middle East**

## Rory S. Smith

**Abstract.** This paper explains and discusses under lifted buildings located in the Middle East. Three case studies are presented. Solutions or partial solutions are presented for the under lifted conditions

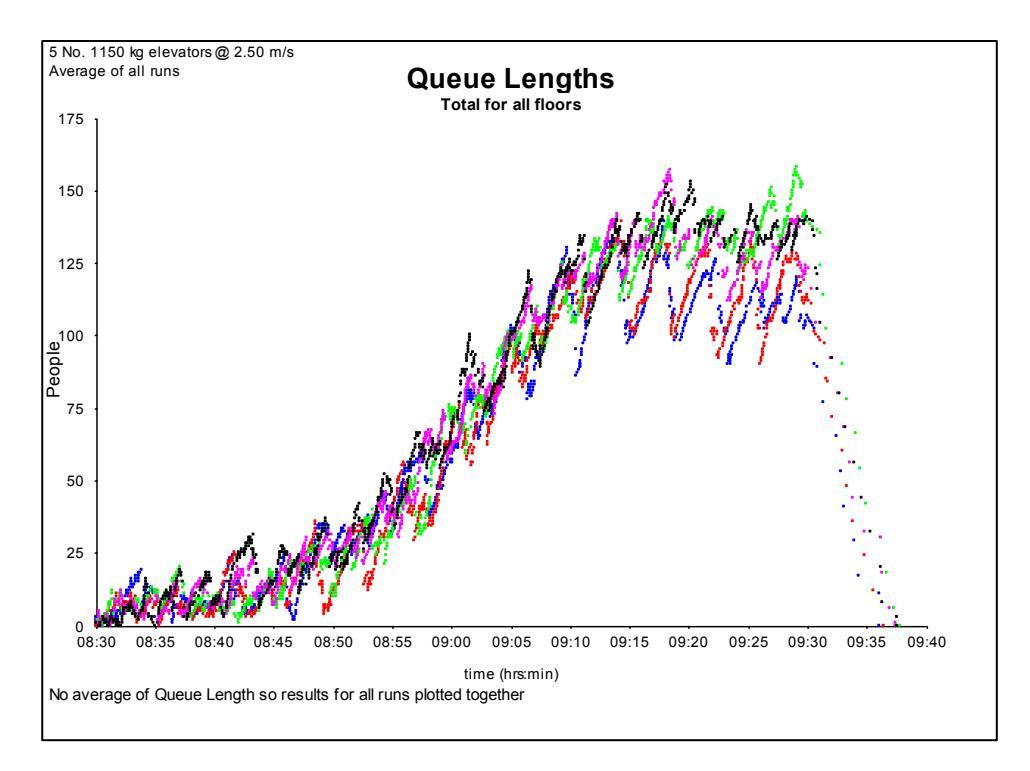
Figure 1Queue Lengths Up Peak

Based on the rule of thumb that there should be one lift for every 3 floors and the suggestion that car park levels should be serviced by separate lifts, the building appeared to be under lifted.

A traffic analysis using Up Peak and Lunch templates from Peters Research was conducted. Figure 1 is a plot of the queue lengths during Up Peak.

Figures 1 and 2 show a system that is saturated.

A destination input control system was recommended for the 5 lifts. Additionally, a bank of 3 lifts was proposed to serve the car park areas.

An alternative method of serving the car park area was proposed; Valet Parking. In Dubai, labor costs are very low in comparison to lease rates. Valet Parking could be viewed as a luxury feature whilst inexpensively solving a vertical transportation problem.
