Optic Technology for the Entrapment Issues of Side of Step, Comb Plate and Lift Doors

Keywords: Escalators; entrapment; side of step; skirt panel; comb plate; lift doors; optic cable.

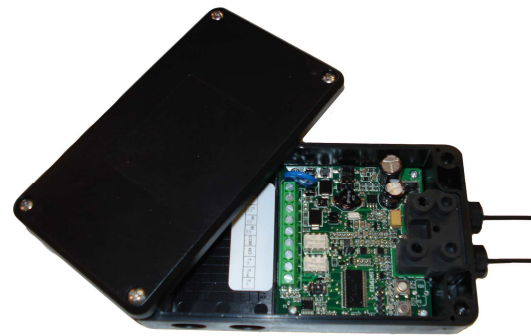
When the pre-set distortion point has been reached "which can be as sensitive as 0.01mm of movement" a signal will be sent from the module unit to immediately stop the unit at its safety function.

- i. 0,01mm of movement is enough for activation
- ii. Accurate in wide range i.e. less than 0,1N to over 10 tons

The closed system is made up of a plastic optical cable and an advanced electronic module. Use is made of a patented system involving the entire spectrum of light that is coupled into the optical cable. Through the software, various colours "put apart", to which the base values are assigned. These base values, as well as the desired bandwidth, are stored in the core of the system and form the limits of detection. When pressure is put upon the cable provided with mechanical break points for distortions in the cable, these distortions result in a change of the spectral distribution of the light in which the changing values belong. Including these new values beyond the set limits of detection, a signal will be given.

Only the kink points caused by the mechanical light changes, at the application of pressure using the pre-determined sensor points, finally provide for the detection. Changes in composition of the light as a result of factors such as dirt, wind, rain, hail, fog, snow, moisture and temperature cannot therefore exert any influence on the operation of the system.

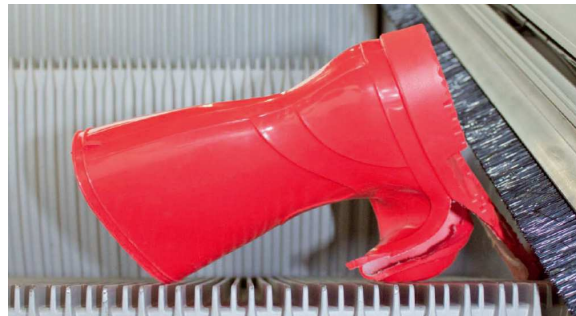
The Skirt Panel detection is mounted at strategic points behind the skirt panels. The sensor points are installed at the centre point of the panel where the most distortion can take place.

The system is pressure sensitive to “force overtime” - the system measures 240 times a second and it is not susceptible to impact blows to trigger the distortion. As is often the case there can be issues of passengers kicking the skirt panels, but the system understands that no pressure is being engaged so will not activate.

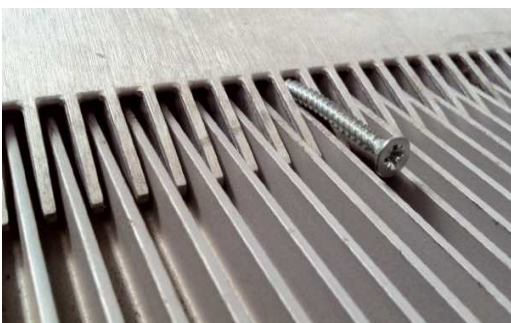
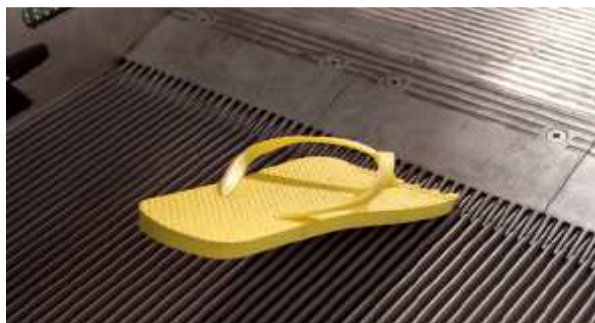
The Comb Plate detection is mounted just in front of the comb plates, on the comb bearer behind the skirt panels. It is mounted in this manner so as not to interfere with the existing safety switches. It can be retro fitted to any manufacture and model of escalator and has the added function of being able to detect vertically and horizontally. As we know for most manufacturers the comb bearer will only function in one movement.

- i. Mechanical setup
 - a) Horizontal & vertical detection
- ii. Alarm
 - a) 1 potential free contact
- iii. Pressure sensitive
- iv. Auto calibration

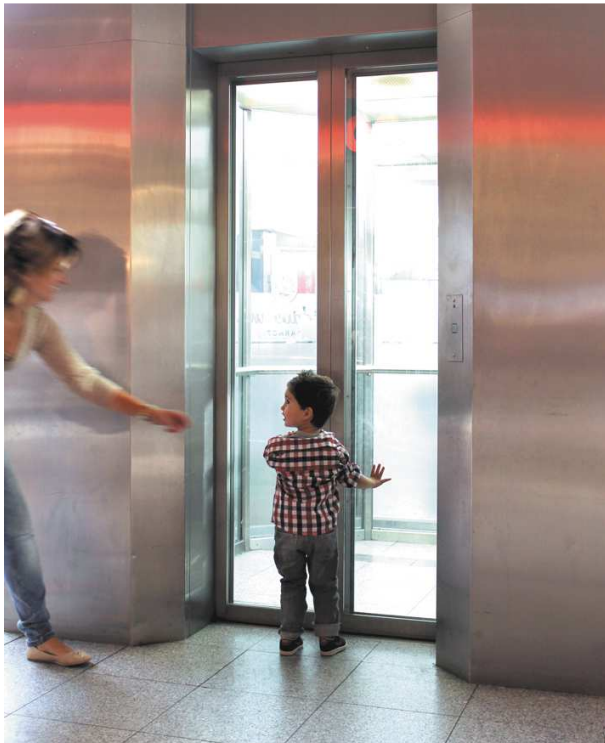
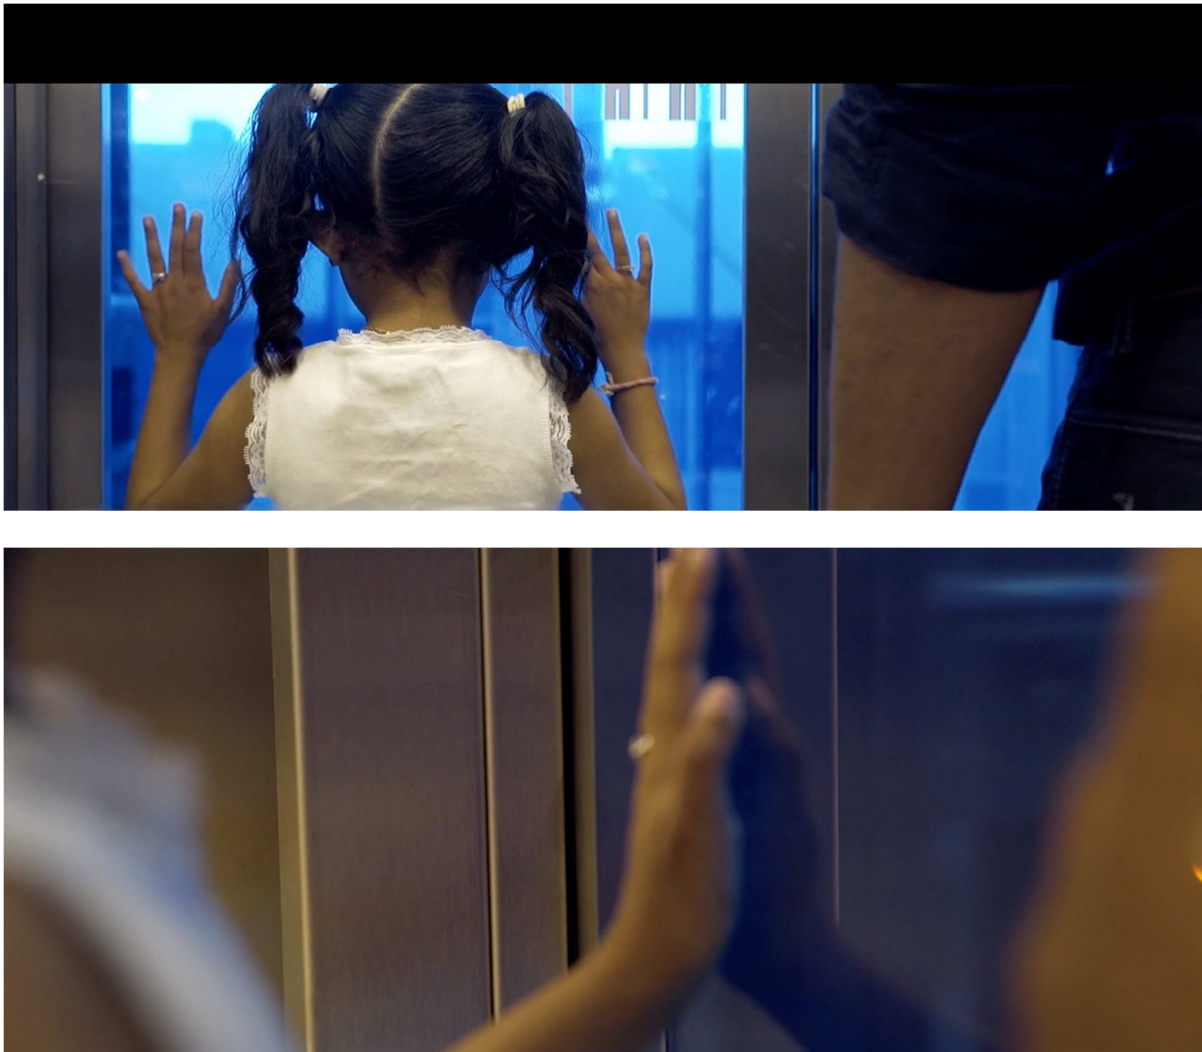
A scenic lift door is a viewing area especially for small children, who often rest their hands on the glass doors. As the car arrives the doors open, the fingers have the potential to become trapped at the door frame.

1. Reducing the coefficient of friction between hands and glass
 2. Making the glass opaque up to a height of 1,10m
 3. Sensing the presence of fingers, or
 4. Other equivalent methods
- i. Mechanical setup
- a) Both the lift car and landing doors
 - b) System is auto-calibrating
 - c) Suitable for metal and glass doors
 - d) Plug and Play installation
 - e) Available for multiple door heights
