Escalator Runaways

David A. Cooper

LECS (UK) Ltd & University of Northampton

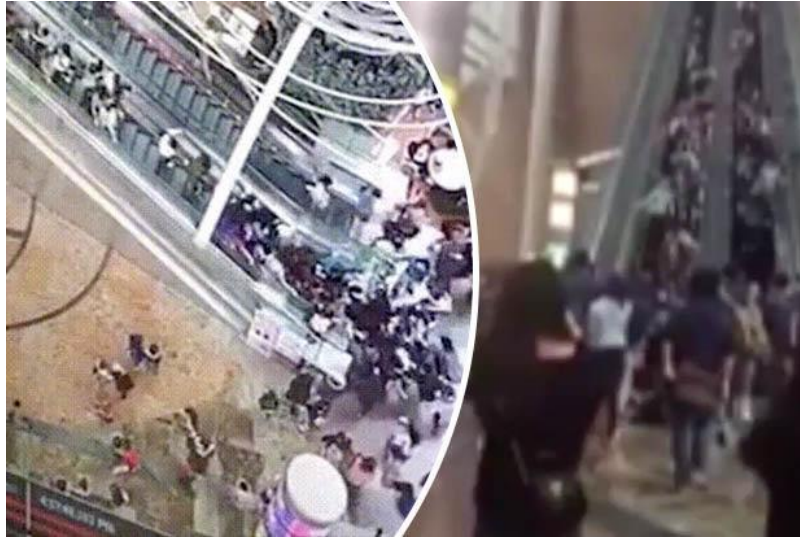
In such situations, and especially when there has been an acceleration component involved, passengers are often deposited in a pile at the bottom end of the escalator due to the inability of passengers to egress the escalator because of its high speed.

An accumulation of passengers can be seen building up in the below photograph, with passengers behind them unable to avoid the passengers at the bottom, as there is no way of escape due to the escalator being installed with a void to the side.

Photograph 1: Passengers at base of escalator in the Mong Kok Mall incident in Hong Kong

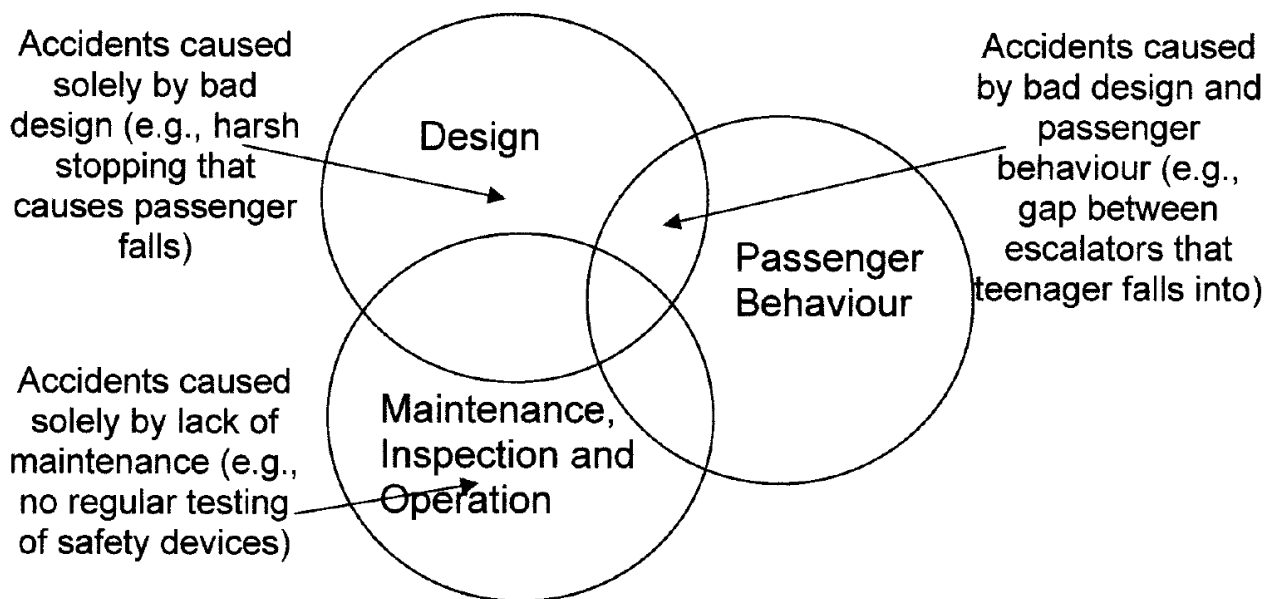
Al-Sharif has previously derived a Venn Diagram (Fig.2) showing seven possible ways accidents with escalators and escalator runaways occur, falling into the categories identified including design, maintenance and passenger behaviour.

Figure 2: Al-Sharif's Venn Diagram of escalator accident causation [2]

When it comes to passenger behaviour, they have not been found to be associated with primary causation of a runaway, but minor contribution such as pressing an emergency stop button, leading to the primary reason for it becoming apparent (e.g. operational brake doesn't hold when required to do so). In addition, it has been found that in the initial stages of an accelerating runaway, passengers continue to board the escalator if it is a down running machine, unaware that it is in trouble.

This leads to the other two components namely design and maintenance.

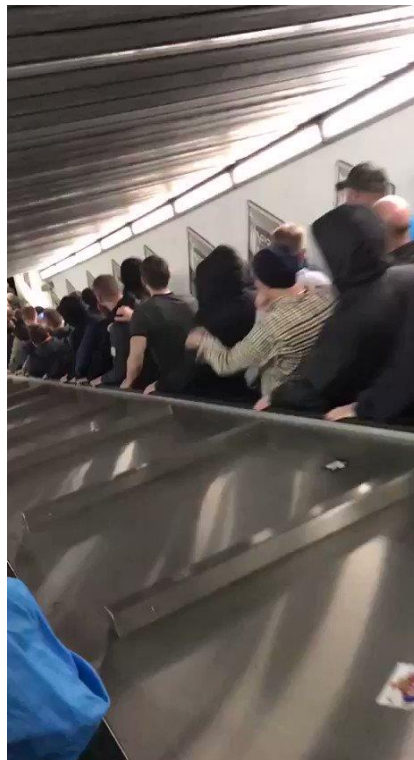
In the incident in Rome, the CCTV footage can be seen showing the escalator slowing down and then increasing in speed.

It appears what has happened, is that someone has operated an emergency stop button and the operational brake has been asked to bring the escalator to a safe stop and hold the step band in position but failed to do so.

It appears the step band starts to accelerate in the down direction causing a passenger crowding situation.

Photograph 2: Passengers, during the initial phase of a runaway, starting to hold the passenger in front.

In the environment where the escalator was installed, it would be expected that an auxiliary brake would have been installed, and on the assumption that it has, then it has clearly failed to arrest the reversal of the step band.
