# A MODERN APPROACH TO OLDER BUILDINGS

C. M. Pearce, Ove Arup & Partners, Sydney, Australia

The development of lift systems has matched, in no small measure, that of the buildings themselves. As buildings have been replaced, the lift system has been part of the new development, with improved control systems, safety features and physical appearance. An increasing number of developers, however, are resisting the urge to replace older buildings, perhaps due to the effects of heritage group pressure, and also to the expense involved in, and restrictions placed upon demolition work. The lift system designer can be left in a quandary with these buildings, whether to offer a completely new system or to utilise, as far as possible, the existing equipment and building style. This paper considers the lift systems in several extensively restored, elderly buildings in Sydney, Australia.

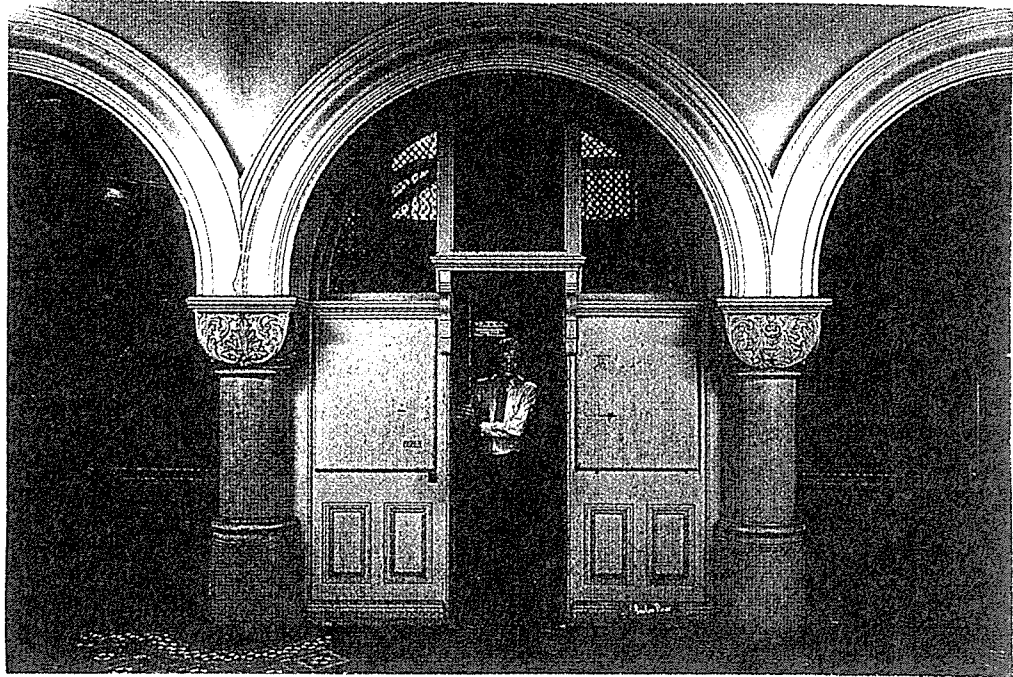
Figure 3 - One of the Passenger Lifts at an End of the Building

The four manually operated passenger lifts remained unchanged until the final renovation of the building. They were considered to be unsuitable for modernisation when the building was restored, and the decision was made to replace them.
