# Why Escalators Require Safety Gear Similar to Lifts

Anthony Andon

**Keywords:** Escalator, Auxiliary Brake

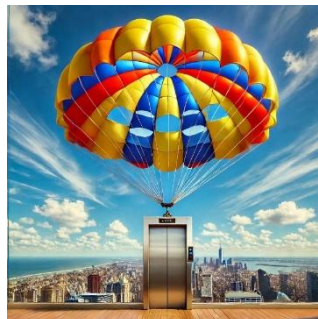
**Figure 1 Conceptual photo of a parachute in an elevator**

After the invention of the lift safety brake by Elisha Otis, it was also called a parachute in lifts. However, just as a parachute includes components such as the pilot chute, bridle, apex, canopy, skirt, suspension lines, links, risers, control lines, harness and container, bag, and manual activator mechanism, the parachute in a lift also does not mean only the safety brake. It includes the governor, tension sheave, governor wire rope, rope clamp, governor engagement microswitch, safety brake engagement microswitch, safety brake, synchronisation lever, etc., which ultimately create safety similar to an aeroplane parachute for the lift. With this definition, an upward parachute does not make sense; rather, the correct term is the safety mechanism to prevent upward overspeed or upward safety brake. Installing a parachute is mandatory for all passenger cabins and, under certain conditions, for the counterweight as well.

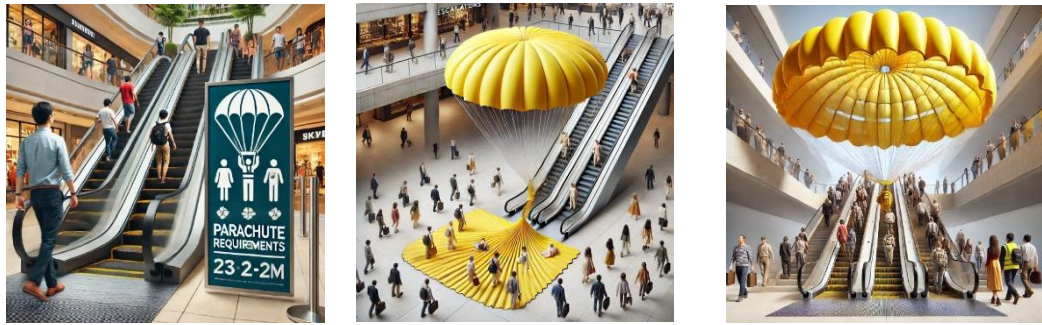
**Figure 2 Conceptual photo of a parachute in an escalator**

Unlike lifts, the parachute mechanism for preventing passenger accidents is not mandated for escalators under EN115-1:2017 [1]. According to sub-clause 5.4.2.2.1 of the standard, auxiliary brakes (similar to parachutes in lifts) are only mandatory under three conditions:

- the connection between the operational brake and the driving sprockets is not accomplished by shafts, gear wheels, multiplex chains, or more than one single chain, or
- the operational brake is not electro-mechanical, or
- the escalator rise exceeds 6 meters.

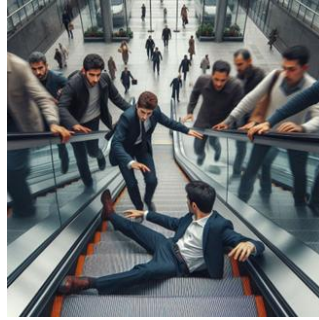
**Figure 3 A simulated image depicting loss of balance due to a sudden change of direction**

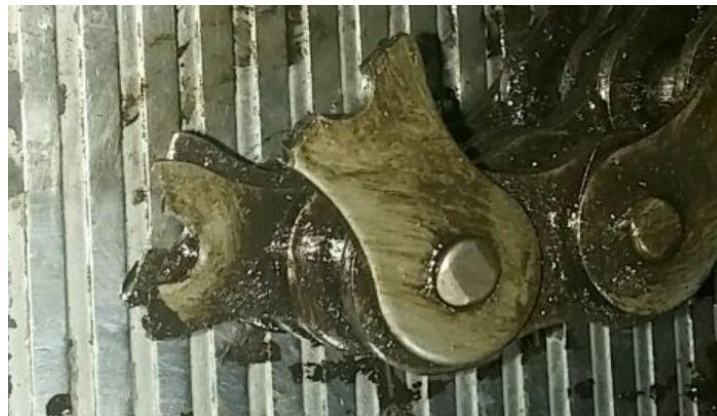
- a) Main chain failure – In most cases, the brake is integrated into the motor, and chain breakage results in the inability to support the escalator steps.

**Figure 4 Main chain breakage**

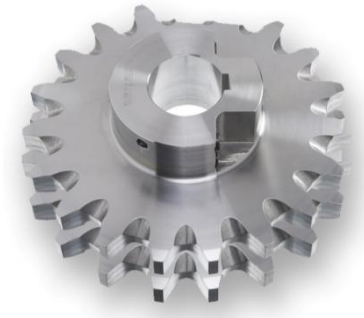
- b) Sprocket failure or chain derailment – The breaking of the sprocket or the main chain slipping off its intended path.

**Figure 5 Simulation of sprocket failure by broken teeth**

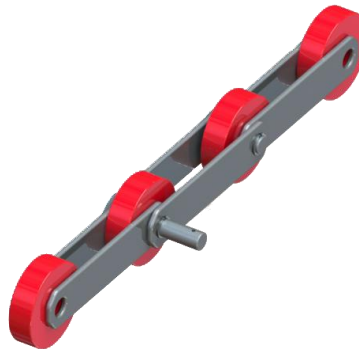
- c) Step chain failure (breakage or derailment) – Step chains breaking or falling off the sprocket, disrupting the escalator's operation.

**Figure 6 Step chain**

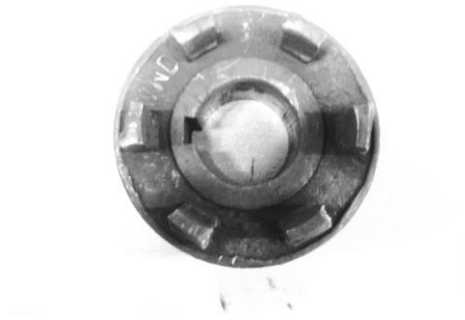
- e) Flange failure – In certain motor designs, flanges are used to prevent gearbox damage from affecting the motor shaft and to facilitate part replacement. In one documented accident, flange breakage was directly responsible for failure. Notably, in 90% of cases, the main brake is mounted on the motor. Consequently, flange breakage can lead to gearbox disengagement, rendering the main brake ineffective in stopping the system.

**Figure 8 Flange breakage**

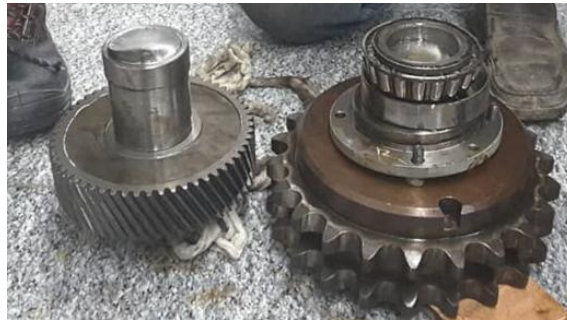
- f) Gearbox failure – shaft or gear

**Figure 9 Gearbox breakage**

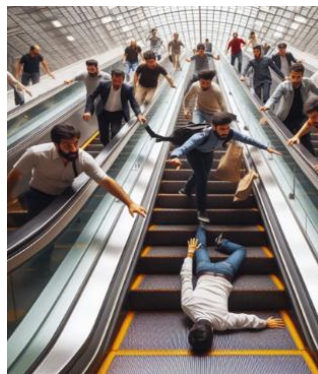
**Figure 10 A simulated image depicting loss of balance due to the overspeed of the escalator**
