# Statistical Investigation of Lift Damages after Large Earthquakes in Turkey

**Abstract.** Lifts are expected to continue their services after earthquakes, especially in critical and strategic public buildings such as hospitals. However, from investigations carried out in the field after earthquakes, it is known that lifts are out of service due to damage to critical components. In this study, after large earthquakes in Turkey, field investigations carried out on lift installations are discussed, and the structural elements of the lifts are classified and statistically expressed. The results obtained are shown graphically, and the distribution of the damages in critical components is given. It is aimed to reveal which components should be focused on in lift design for earthquakes and the points to be taken into account in lift design for seismic test suit. Although the EN 81-77 standard was introduced in Turkey in 2014, it has been observed that the standard is not mandatory, and the structural characteristics of the damaged lifts during the period are the same.

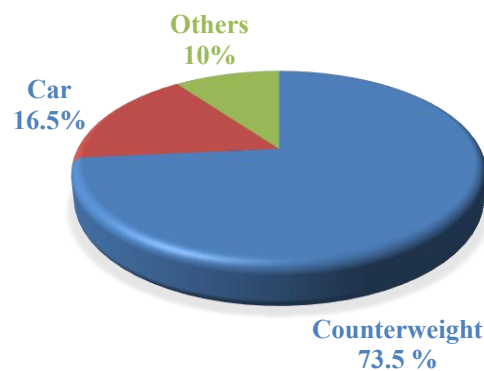
(a)

As a result of the research and observations made in the field after the major earthquakes in Turkey, the percentage distribution of damage to lifts is shown in Figure 5. While examining the statistical data, the lift system is divided into the car part, counterweight part and others (Figure 5 (a)). The counterweight part consists of rail, shoes, bracket, cables and counterweight, and the part that includes all the elements here can be referred to as the rail-counterweight system. When the earthquake statistics are examined, it is seen that the total damage rate of the rail-counterweight system is 73.5%. According to statistical data, the most common type of damage is derailment of the counterweight (Figure 5 (b)).

**Figure 5 Percentage of damage types in lifts**
