COUNTERWEIGHT EVOLUTION

John Inglis, Code Consultant, Killara, Australia.

This paper will review the evolution of the counterweight from the very early days, when man wanted to make his work easier. There have been many designs of counterweights used and adapted to cater for changes in technology. The counterweight tends to be the forgotten component in the total lift package. It is hoped that this presentation may inform and record this evolution for future generations.

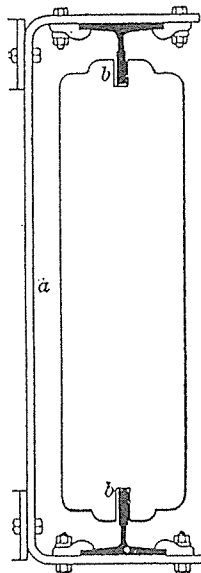
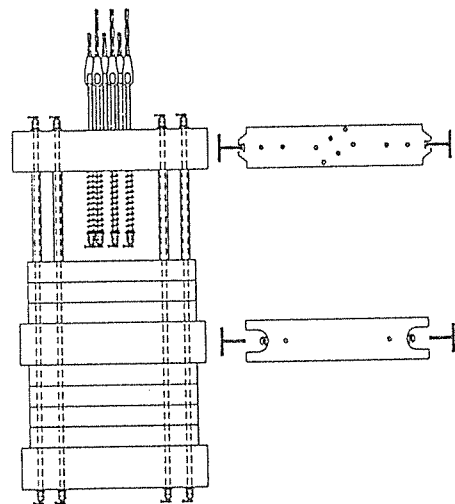
GUIDE SHOES AS PART OF TOP AND BOTTOM WEIGHT.

The very early counterweights ran on timber guides, the guide timber was a hard wearing timber like tallow wood. This system allowed for very primitive guide shoes such as slots in the bottom and top weight. There was no guide shoe adjustment.

Even in the early days of metal guide rails the method of using the top and bottom weight as fixed guides applied.

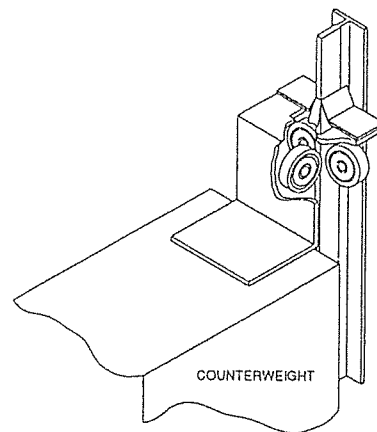
GUIDE SHOES INCORPORATING ICEBREAKERS.

Counterweights in high towers exposed to the very cold environment have had to be fitted with "Ice Breakers" or scrapers to keep the rails clean.

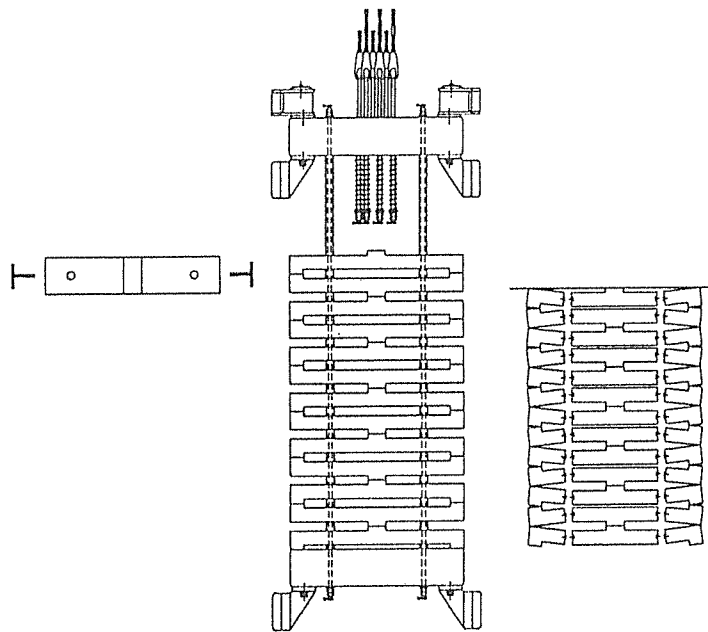
CRASH WEIGHT.

The sketches shows a very early method of reducing the impact on pit floor in the event of suspension failure. This applied to smaller lifts where the counterweight was above occupied space. Its main disadvantage was that it was a "ONE HIT" solution that broke all the filler weights which would have to be replaced. The breaking of the filler weights reduced the inertia in the system so reducing the impact on the pit floor. The left hand

sketch shows the normal arrangement, the right hand sketch shows the broken weights and the reduced height of the filler stack. The design of the fillers had to ensure that under normal counterweight buffer engagement the fillers did not break, yet have spaces between the fillers to allow the maximum space for the broken fillers to occupy, so causing the maximum reduction in the filler stack.

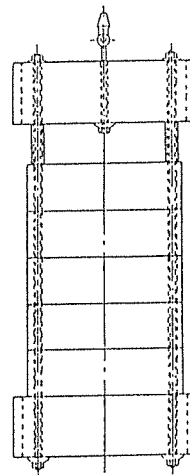
ROD TYPE WEIGHTS.

This type of weight construction was very popular in the early days of drum and traction lifts. It was used for a longer period of time with the smaller companies because of its flexibility and lower manufacturing involvement. The larger manufacturers with structural steel plants changed to the frame weight particularly as lift speeds increased.

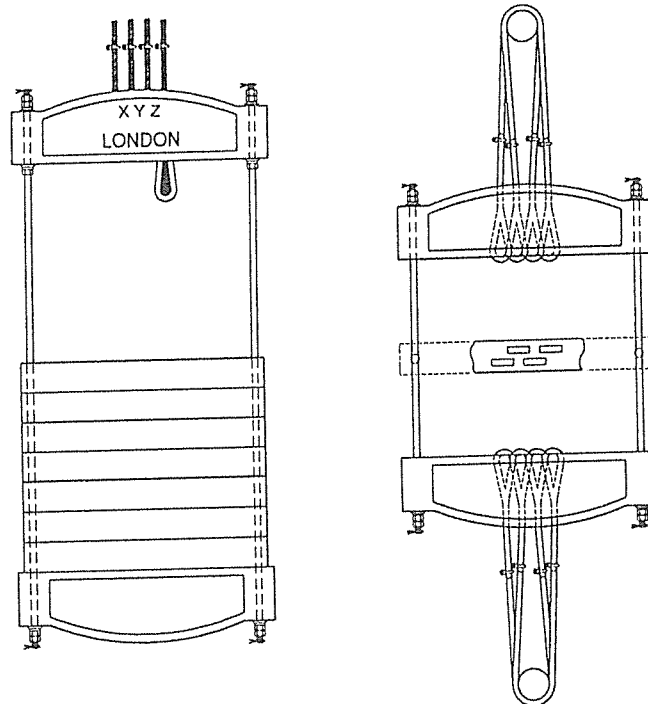
TESTING WEIGHTS AND ROPE ANCHORAGES.

In the early days of rod type counterweights a variety of top weights (sometimes called King weights) were manufactured from cast iron. These weights in many cases had the companies name cast into the weight as shown in the sketch.

At an engineering lecture given in the 1924 a method of casting wedge shaped holes in this top weight for direct anchorage of ropes must have been one of the earliest applications of wedge type sockets in the lift industry.

This introduction of rope anchorage and top weights was also subjected to a test for the strength of rope terminations and the top and bottom casting connected by the standard rods to be used. One of the tests carried out on a passenger lift weight resisted a strain equal to 30,000 Kg.

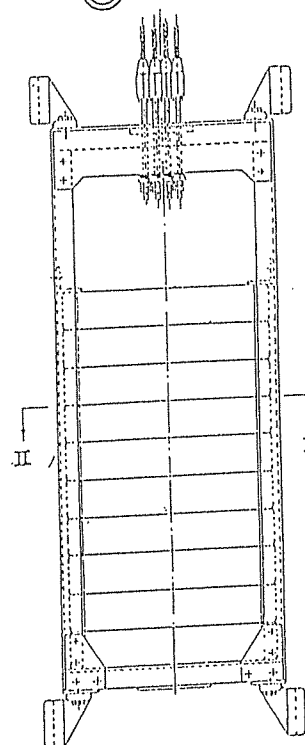
FRAMED WEIGHT.

After many countries had placed bans on rod type weights for high speed lifts and lifts in earthquake areas, the most popular type of construction was the framed weight. In the days prior to arc welding these frames were fabricated from channel iron and plate construction riveted together. The assembly of these counterweights in the field was much easier than the rod type construction and much safer for the construction worker. The rod type weight was very difficult to load the fillers onto the rods and maintain the stability of the partly built stack which unlike the framed weight had no top guide shoes until the top weight was fitted.

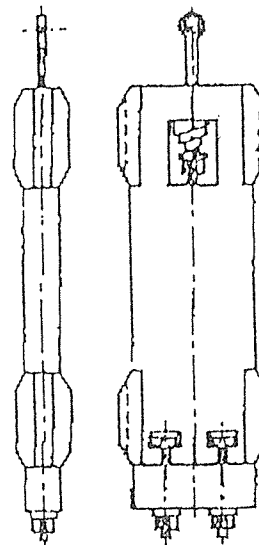
SLAB COUNTERWEIGHTS.

The use of a single piece counterweight has both advantages and disadvantages which should be considered before deciding on this form of counterweight construction.

Not easy to add or subtract additional weights except as shown at the bottom of weight assembly.

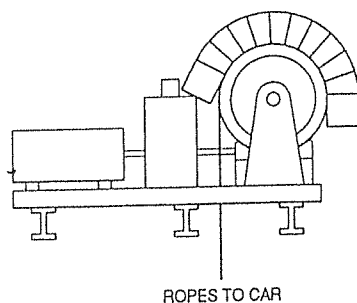
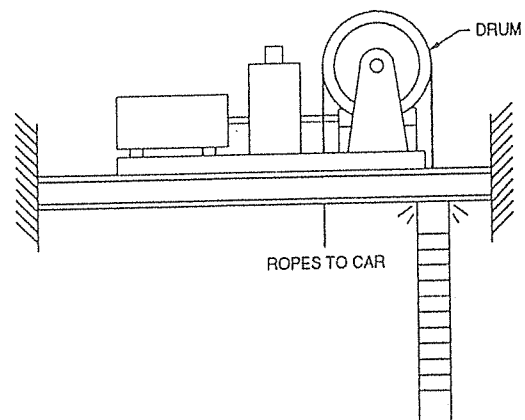
The sketches show how in some cases the machine over wound and pulled the counterweight into machine room. The second sketch illustrates how the machine beam location can prevent the counterweight being pulled into the machine room but at the same time brings the counterweight to an abrupt stop. This sudden stop has been the cause of many ropes breaking or terminations failing, thus allowing the counterweight to free fall to the pit.

Jamming of car in the shaft on a down direction run has allowed ropes to become slack, stopping the machine by the opening of the slack rope switch. This situation has not been fool proof, there have been cases of lift mechanics operating the controls manually and winding rope off the drum and then winding the rope back onto the drum in the wrong direction.

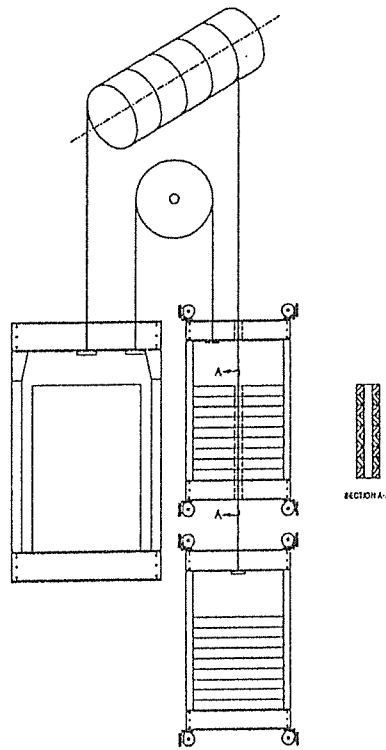
Prior to the counterweights being forbidden on drum driven lifts two counterweights were installed in the same guides. The bottom weight was for the car and the ropes passed through the top weight. The top weight was fitted for two reasons firstly to reduce the load on the drum machine and secondly to avoid larger or additional ropes being required.

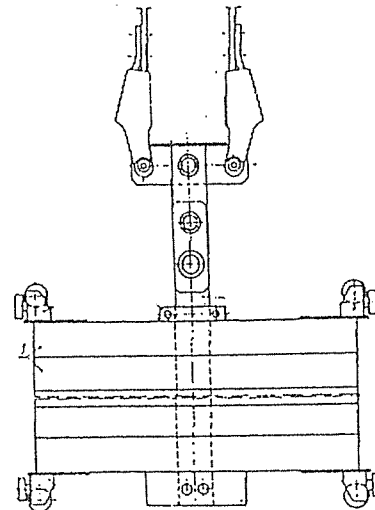
Single pickup counterweights have failed allowing the counterweight to free fall to the pit. Even though there were two ropes between the machine and counterweight attachment was via an equaliser bar that only had one point connection to the counterweight.

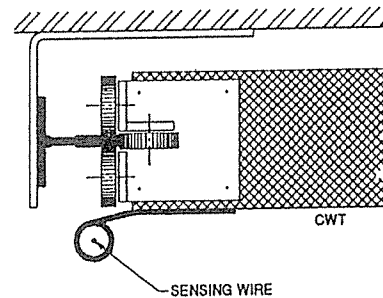
There are several reasons for counterweights coming out of the guide rails, firstly earthquakes can cause the distance between the guide to be increased to such an extent that the guide shoes become disengaged. The guide rail separation can be due to failure or loosening of rail brackets many of which have slotted fixing hole for adjustment during installation.

In some cases the brackets are independent and the building construction fails between two brackets at the same level.

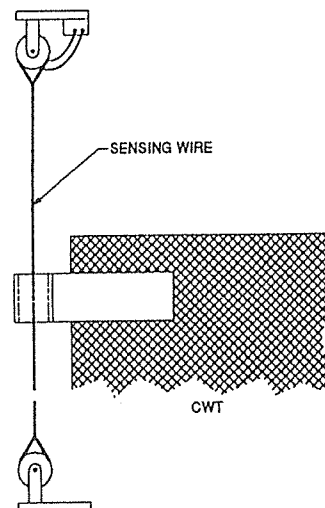
During earthquakes it is possible for the counterweight to come out of its guides, with a lift travelling at fast speed this can be a major disaster. To protect against this a displacement detector like that shown in the sketch will stop the lift when the sensing ring on the counterweight touches the sensing wire

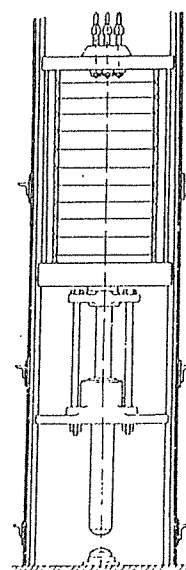
BUFFERS MOUNTED BELOW COUNTERWEIGHT.

The addition of oil buffers to the bottom of counterweights gave additional weight to the counterweight, this in turn reduced the weight of fillers to be used by the weight of the buffer assembly. Gravity caused the buffer to reset as the counterweight was moved up off the pit stop

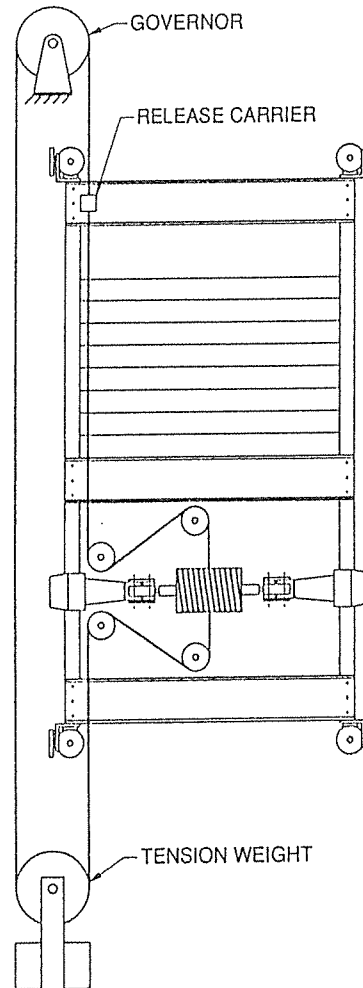
SAFETY GEAR ON COUNTERWEIGHTS.

The addition of safety gear to counterweights is often required to suit the following emergencies; to prevent up runaway cars, to prevent free fall of the counterweight in the event of suspension failure. Depending on the contract speed the safety gear can be instantaneous, sliding or oil cushion types.

Wedge clamp Safety Gear on a counterweight causes a major problem regarding the resetting of the equipment after it has operated. The sketch shows one method of overcoming this problem by having the rope drum with a rope coming off each side, that is one rope shown on the topside of the drum that pulls the safety gear onto the rails and the other rope shown at the bottom at the same time winding onto the drum. To release the safety gear the mechanic can enter the pit and pull on the rope that connects to the bottom of the drum, this will unwind the safety gear and at the same time reset the top actuating rope. This arrangement can be released if the suspension means has failed, but if released completely the counterweight will descend at excessive speed causing the governor to operate and reset the safety gear.

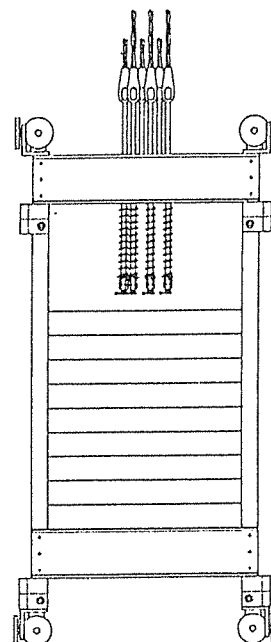
DUPLEX SAFETY GEAR

DUPLEX SAFETY GEAR.

The space available in lift shafts is usually limited in the plan view, yet in most cases the elevation is not so restrictive. For large lifts that require safety gear to be fitted to the counterweight the standard safety gear may be too large in the plan dimensions. This is where duplex safety gear can be fitted, sketch illustrates a counterweight frame fitted with two safety blocks at each end. The type of safety gear is of the type that resets by moving the car in the upward direction. Normally the safety gear blocks are of equal capacity but if unequal capacity pairs are used the larger capacity should be fitted to the bottom of the counterweight frame.

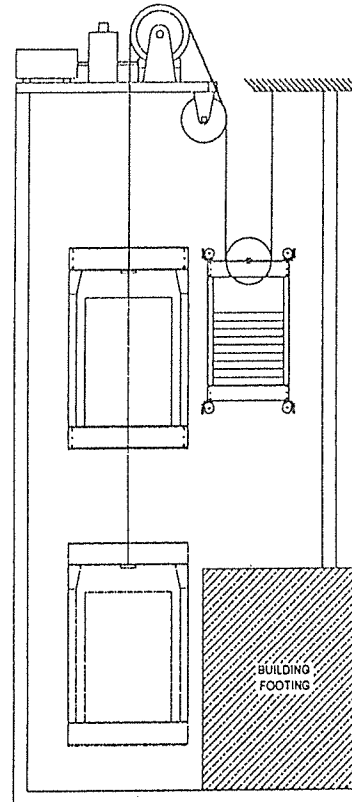
COUNTERWEIGHT ROPING RATIO CHANGE TO SUIT BUILDING FOOTINGS.

Car 1:1 counterweight 2:1

Building footing have often caused the installer major problems, when the pit has been excavated large footing were found that could not be removed. These obstructions were below the path of the counterweight reducing the required travel. By roping the counterweight 2:1 and leaving the car at 1:1 the problem was solved.

This solution has some drawbacks in that the counterweight now is required to be twice the previously required weight due to the 2:1 roping, but only travels half the distance of the car.

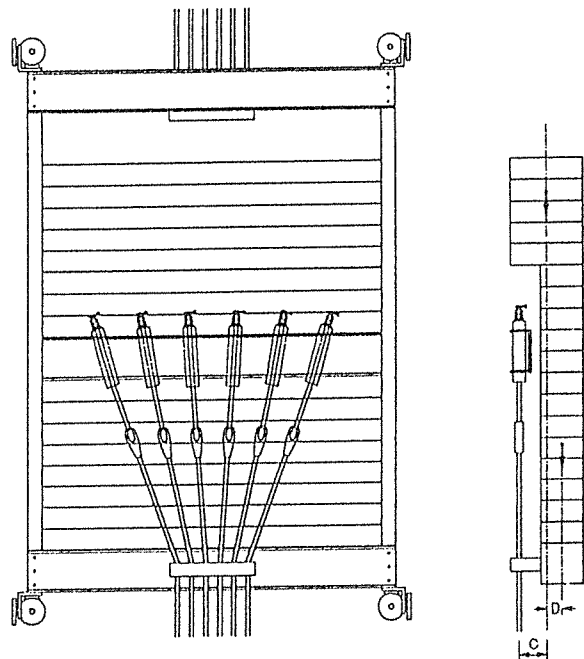
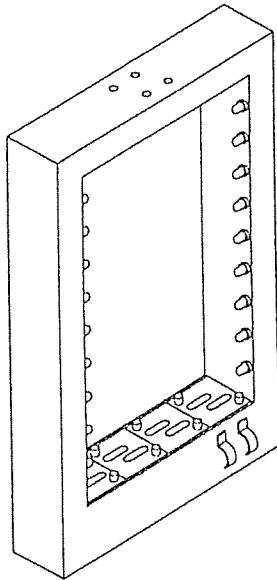
COMPENSATION ROPE OR CHAIN ATTACHMENT.

Following the increased height in buildings chain compensation was followed by rope compensation. This then required compensating ropes to be attached to the counterweight. Initially the ropes were connected to the underside of the counterweight, but as this required additional pit depth the ropes were connected to the face of the counterweight. This reduced pit depth but increased the distance between the car and counterweight. The sketch illustrates how some manufacturers recessed the compensating rope attachments into the front face of the counterweight. Care had to be taken with the location of guide shoes to minimise the shoe loadings, depending on the height of the building the loading on shoes changed from the weight of the compensating ropes, this was partly offset by moving the shoe centre line closer to the rope centre line and allowing the offset of the counterweight to provide a counteracting load.

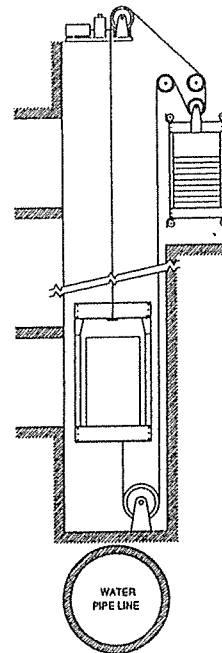
TENSION WEIGHT.

Designers may be faced with a situations where the falling of an uncontrolled weight could have devastating effects. Such an example was where a lift shaft located directly above the main pipeline supplying water to a city. A second problem the there was not enough space in the shaft for a counterweight fitted with safety gear. A tension weight method was used where the weight was outside the line of the shaft at the top landing and there was a fixed sheave in the pit.

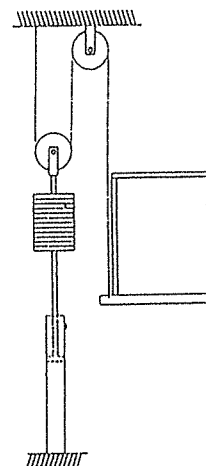
COUNTERWEIGHTS ON INDIRECT HYDRAULIC LIFTS.

The sketch shows a typical use of a counterweight on an indirect hydraulic lift using a pull down ram and cylinder. The main advantage of such a counterweight arrangement is to reduce the power required to raise the fully loaded car. Care must be taken to ensure that half the weight including ram and sheave is not excessive (for 1:2 roping), an approximate guide is 60% of the empty car weight other wise the empty car will not descend on its own.

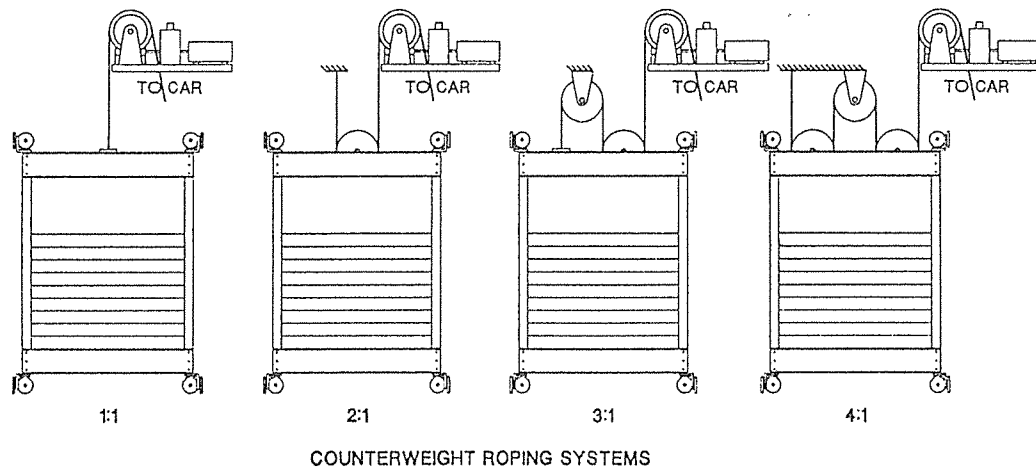
ROPING RATIO FOR HEAVY DUTY APPLICATIONS.

2:1, 3:1, 4:1 roped machines allows smaller machines to be used but as the ratio increases the rope life is reduced due to the number of reverse bends.

Machine sheave speed can be very high when using 4:1 roping of counterweight and car.

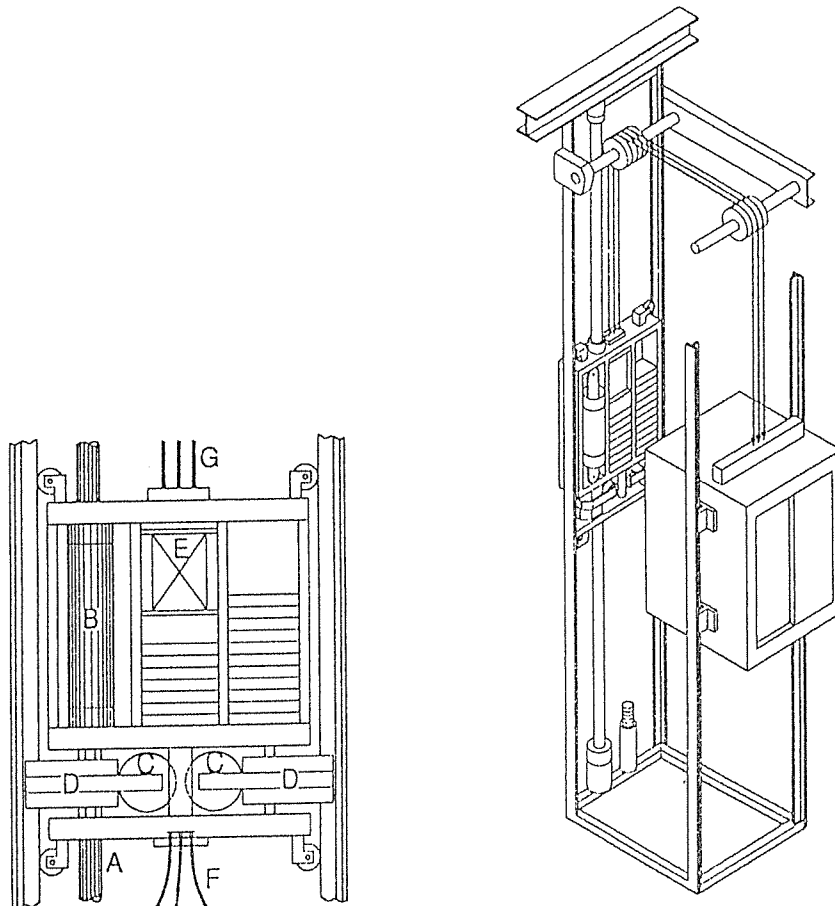
LINER MOTOR AND COUNTERWEIGHT.

The earlier developments of the liner motor drive system placed the motor on the lift car which increase the load on the ropes and machine shaft. Next it was added to the counterweight which reduced the load on ropes and machine.

The latest version first included the brake into the counterweight then proposed that as ropes are now so reliable that the safety gear could be dispensed with on the lift car as the brake on the counterweight could stop and hold the lift.
